This paper describes the service experience gained from G60-, G70-, G80-, and G95-GI engine types.

Service experience for Everllence B&W ME-GI two-stroke engines

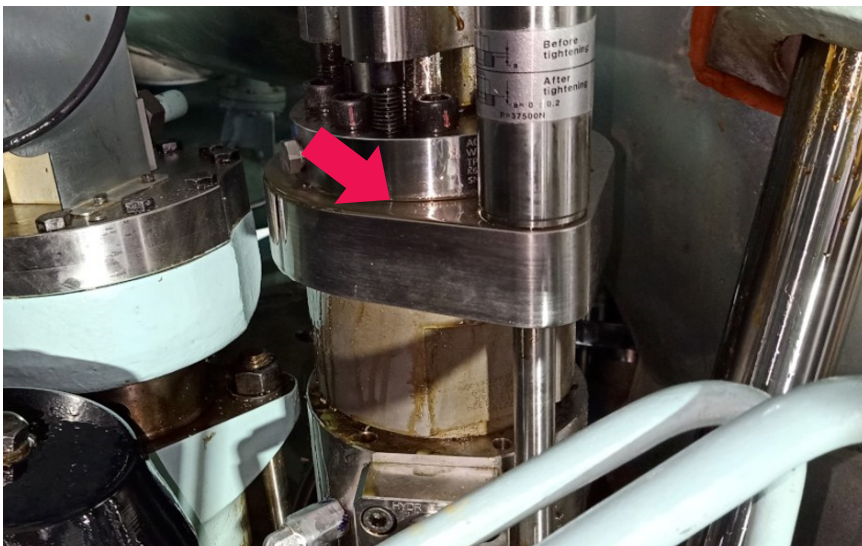
The top cover of the pilot booster injection valve (PBIV) has been observed leaking hydraulic oil from the top cover (Fig. 10), sometimes after only a few hundred running hours.

Fig. 10: Pilot oil and fuel booster injection valve (PBIV) top cover leakage

The solution has been to replace the Viton O-ring shown in Fig. 12a with the PU seal shown in Fig. 12b, which is equally easy to install as the original Viton O-ring.

The new PU seal has resolved the leakage issue on the top cover of PBIV.

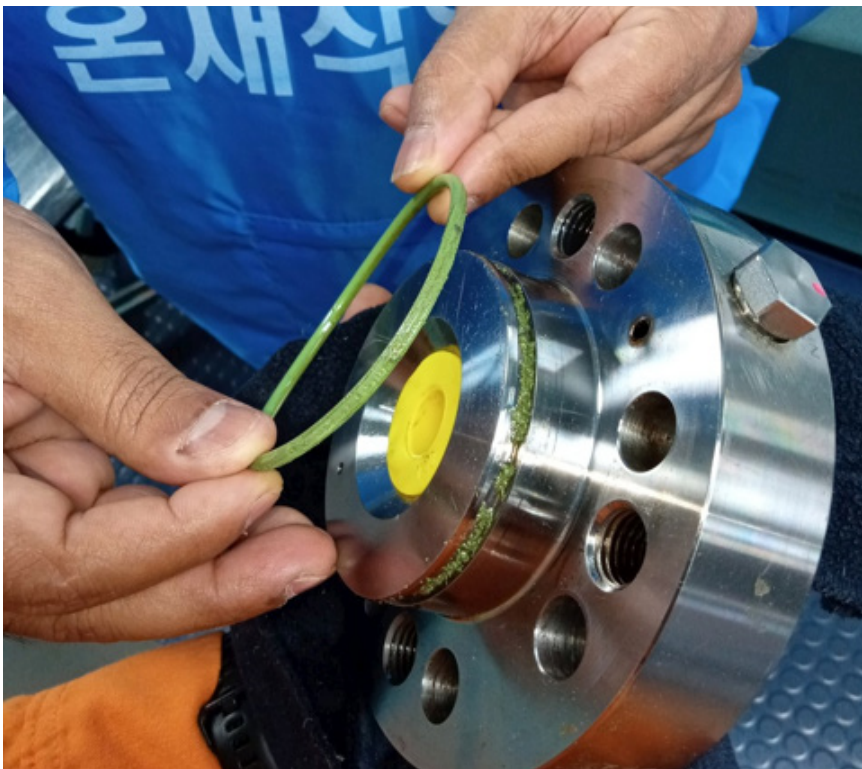
Leakage has been observed in most types of PBIV across various engine types. The root cause has been identified as the Viton O-ring in the top cover (Fig. 11), which becomes too soft and eventually disintegrates.

Fig. 11: Viton O-ring becomes too soft and disintegrates

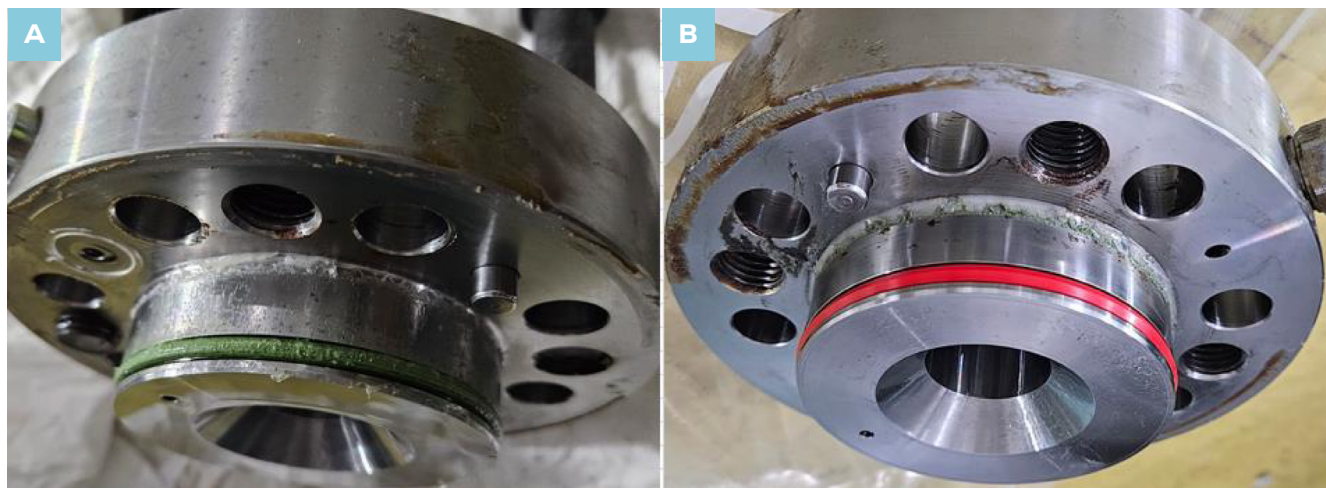
Fig. 12: The PU seal (b) has replaced the Viton O-ring (a), which caused leakage from the top cover

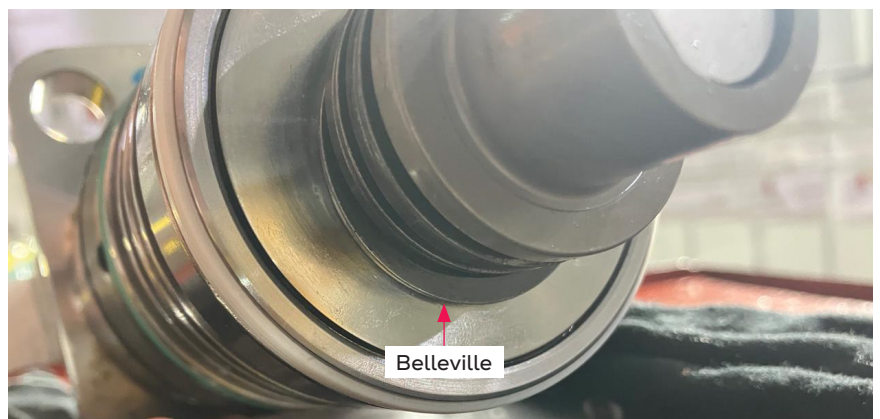
As shown in Fig. 15, when installing the first version of the WVFC, a Belleville spring could drop down and get wedged between the WVFC and the gas block.

Fig. 15: The spring cup was introduced in a revision of the design

Fig. 16 shows the spring cup, which was introduced in a revision of the WVFC design, to prevent the spring in dropping down and getting wedged between the WVFC and the gas block.

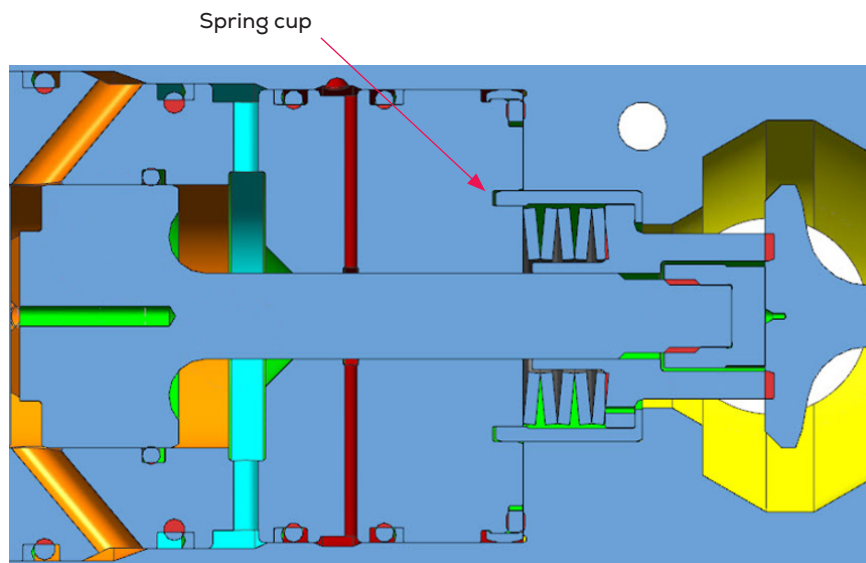
Fig. 16: Belleville spring could drop down and get wedged between the WVFC and the gas block

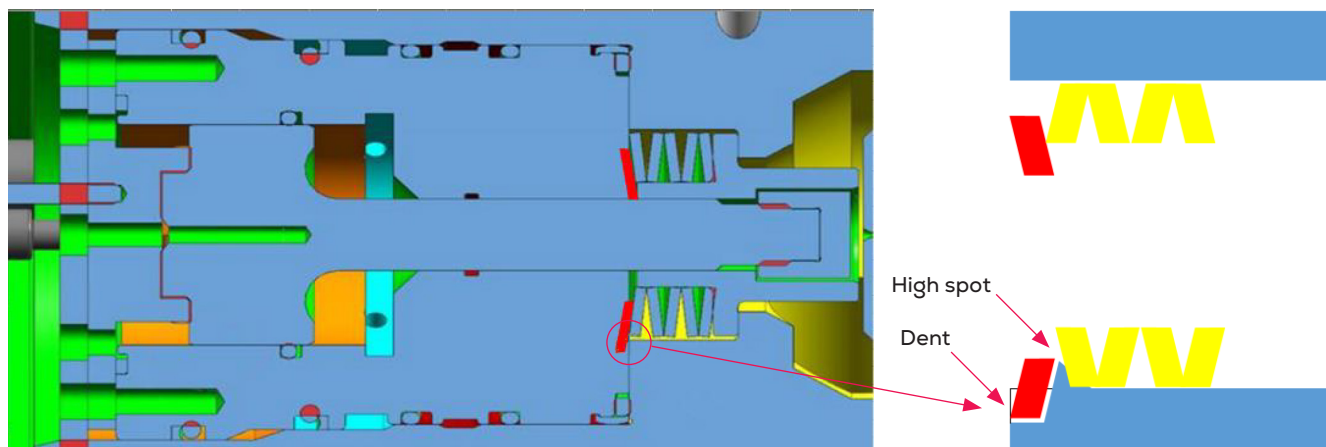
This design change has eliminated the risk of springs dropping down and the associated risk of gas block damage during WVFC assembly. Fig. 17 shows a schematic illustration of gas block damage because the Belleville spring had dropped down during the installation of the original WVFC design.

Fig. 17: Schematic illustration of gas block damage caused by the Belleville spring dropping down during installation of the original WVFC design

Updated instructions have been issued to guide the crew when mounting a WVFC of the original design.

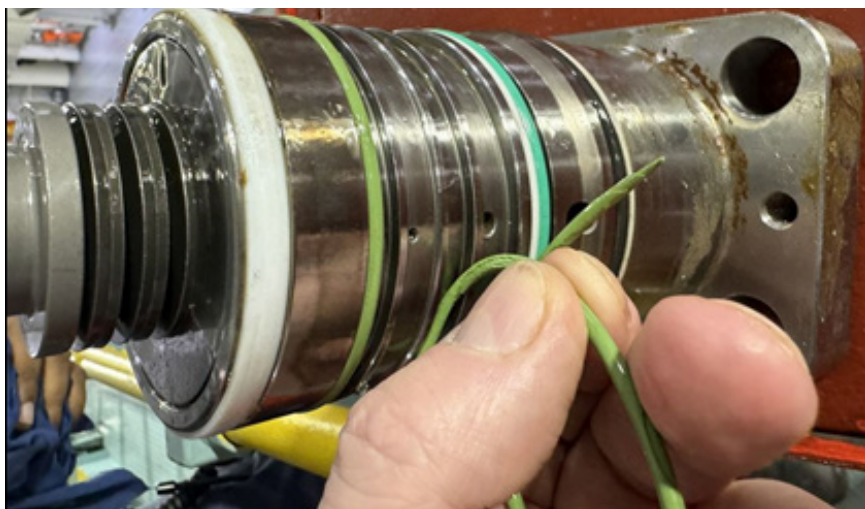
In the WVFC, O-rings kept breaking, leaking sealing oil internally to either the outer pipe or sealing oil return/drain lines. As Fig. 19 shows, one reason was a rapid deterioration of O-rings.

Fig. 19: O-rings deteriorating rapidly, leading to internal sealing oil leakage

The solution has been to change the O-ring material and to introduce an uncut backup ring design. To mount the new uncut backup ring, an expander tool must be used.

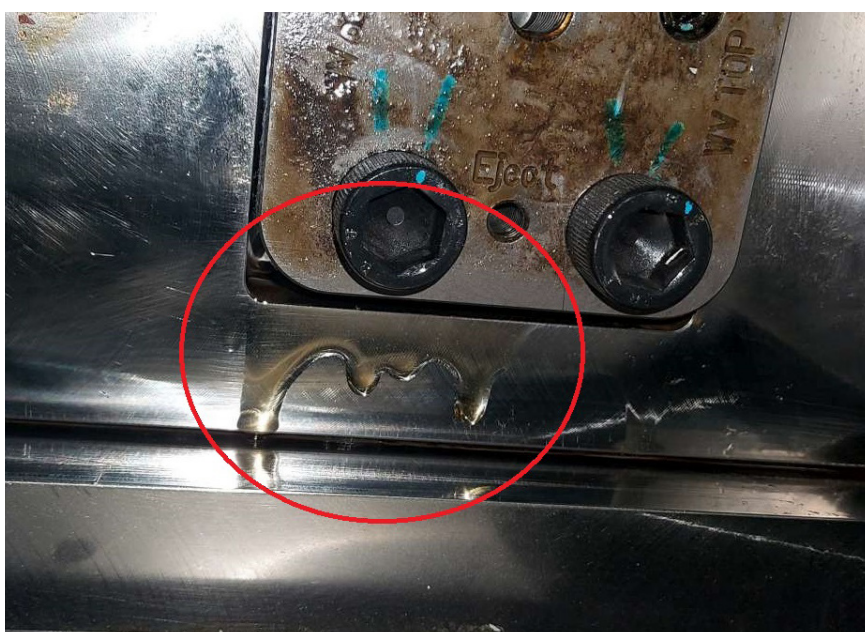
Fig. 21 shows a window valve leaking hydraulic oil externally.

Fig. 21: External sealing oil leakage from the window valve

The leakage would get progressively worse until it affected the operation of the window valve, eventually causing dual-fuel shutdown and switch to liquid fuel oil mode. The window valve had a backup ring with an oblique cut that could

The solution has been to introduce an uncut backup ring design. Also in this case, an

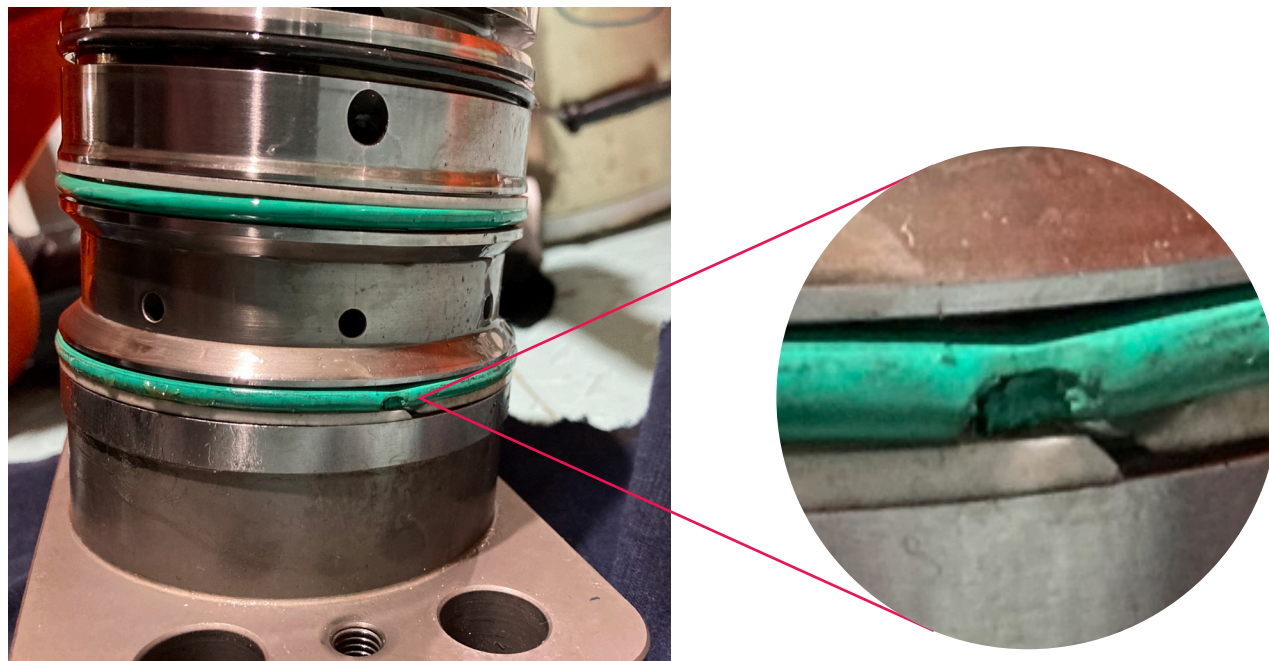
damage the O-ring, and lead to its rupture. Fig. 22 shows the backup ring and the oblique cut damaging the O-ring.

Fig. 22: The backup ring and the oblique cut damaging the O-ring

expander tool must be used to mount the new backup ring. Fig. 23 shows all eight positions where the sealing design has been updated for the WVFC and window valve in new engine production and engines in service.

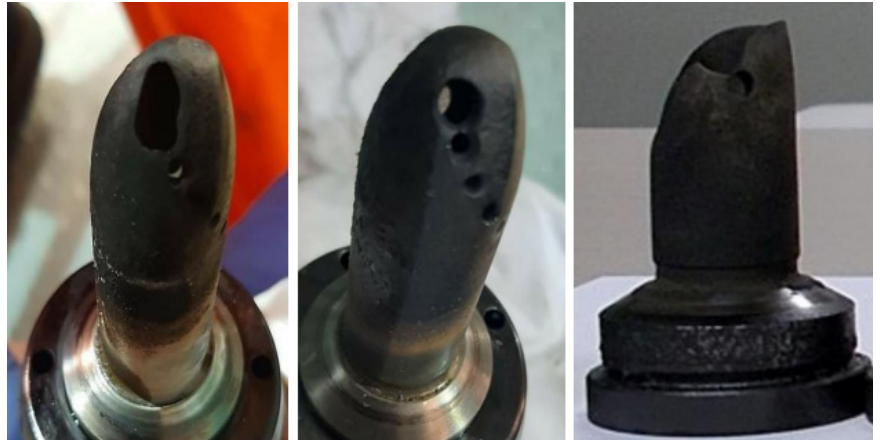
The original long design of gas nozzles suffers from hot corrosion. Fig. 24 shows an example of heavily hot-corroded long nozzles from a G60ME-C10.5-GI Mk. 2 engine.

Fig. 24: Long nozzle design with heavy hot corrosion

To achieve an optimal nozzle tip temperature and prevent hot corrosion while avoiding nozzle clogging, the shorter nozzle designs in Fig. 25 have been investigated. The temperature of the nozzle tip is an important parameter in avoiding nozzle hot corrosion and clogging.

The extra-short nozzle design in Fig. 25 is running without clogging and with acceptable levels of hot corrosion for 8,000 hours in G70ME-C9.5 engines. However, clogging remains an issue for G70ME-C10.5 engines, where nozzles that are 5 mm longer will be tested as a potential solution.

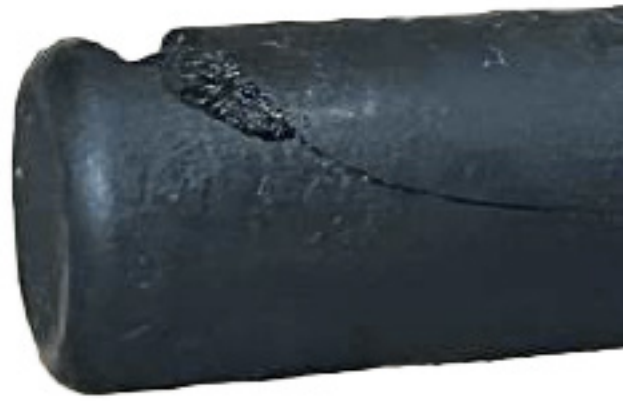
In several instances, the original compound-type PIV nozzle has experienced cracking caused by thermal fatigue, as shown in Fig. 28.

Fig. 28: Original compound type PIV nozzle with cracks

Presently, a PIV nozzle in H13 tool steel is being service-tested, and the crack issue is under control. However, this nozzle suffers from clogging of the small pilot oil injector holes. Fig. 29 shows the test setup for testing larger pilot oil injection holes and an increased number of injection holes to reduce the frequency of clogging.

As a short-term countermeasure, we recommend deactivating the reduced lift (RELI) function and introducing corresponding modifications to the system parameter file (SPAF). This will reduce the risk of clogging; however, it will increase the pilot oil amount somewhat.

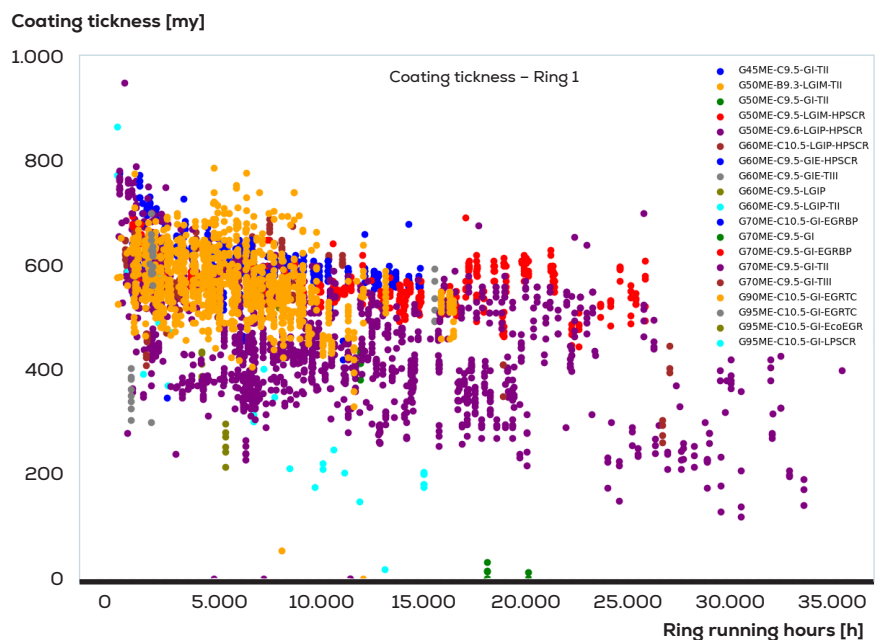
Fig. 30: Plot of top ring coating measurements for all dual-fuel engine types. Data includes over 35,000 piston ring running hours

coating wear determines the need for piston overhaul as this coating is meant as a 'lifetime' coating. Our database of coating thickness recordings for all sizes of ME-GI engines in Fig. 30 demonstrates a remarkably long coating lifetime, easily achieving 32,000 hours (or five years) of operation between piston overhauls.

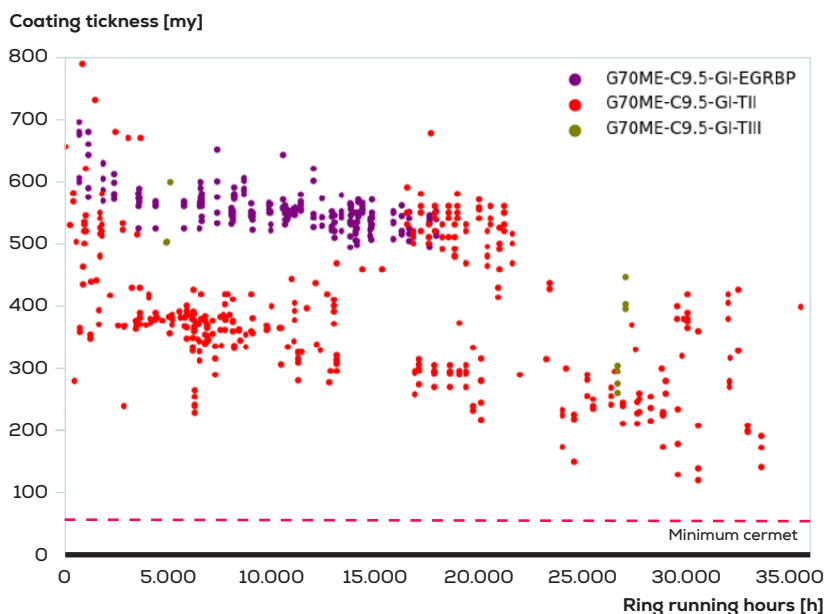
Naturally, there may be occasions when earlier piston overhauls are necessary due to other factors, such as piston ring breakage or loss of tension. However, dock-to-dock operation without piston overhaul is standard practice for today's ME-GI-powered fleet. Fig. 31 presents a subset of cermet coating thickness data for the G70-C9.5-GI engine, which has the highest number of running hours.

Fig. 31: Measurement of cermet coating thickness on the first piston ring. Data collected from nine vessels, encompassing 17 engines and a total of 85 cylinder units, over a five-year service period

In 2019, the Service Letter in Fig. 32 was issued to announce the extension of the piston overhaul interval for 70-bore engines from 16,000 to 24,000 hours – a decision based on the data in Fig. 30 and Fig. 31.

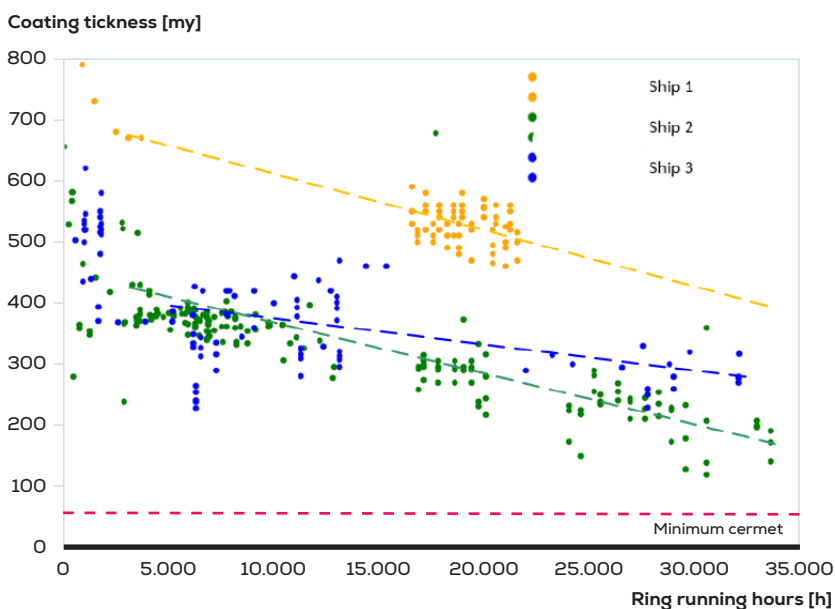
However, data indicates that a further extension of time-based intervals beyond 24,000 hours is possible – see Fig. 33.

Fig. 33: Cermet coating thickness on the first piston ring, measured on three ships and a total of 30 cylinder units

Currently, some owners are already benefiting from condition-based piston overhaul intervals of 32,000 hours, allowing for dock-to-dock operations with five years between dockings.

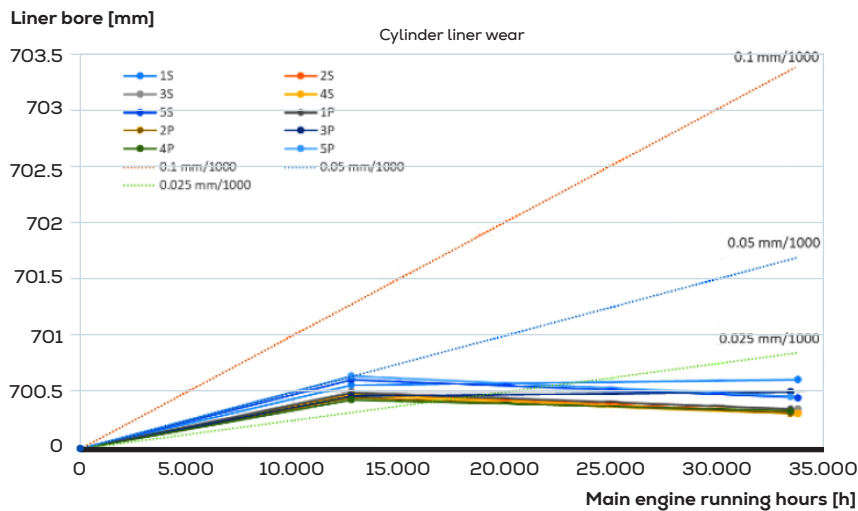
Fig. 34 shows a further subset of data for G70ME-C9.5-GI engines, indicating very low cylinder liner wear.

Fig. 34: Measurement of cylinder liner wear during a five-year service period In fact, the cylinder lifetime approaches the engine lifetime
