Four-stroke Small bore

October 2025

## Rework of crankshaft journals

This Service Letter specifies the limits for reducing main bearing and crank pin journals

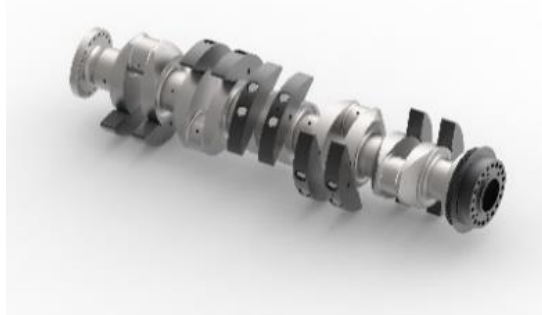
In-situ machining is a well-proven repair method. However, it has some limitations especially in the alignment of the crank web journal in relation to the main bearings.

We therefore consider this repair method as an “emergency repair” that can be accepted for rework of not more than 2 crank pin journals. If more journals need to be machined, Everllence recommends to replace the crankshaft with a new one before sending the damaged crankshaft to a qualified repair shop for machining.
