Two-stroke

Copenhagen, February 2026

Action code: AT FIRST OPPORTUNITY

Cavitation in hydraulic push rod for exhaust valve

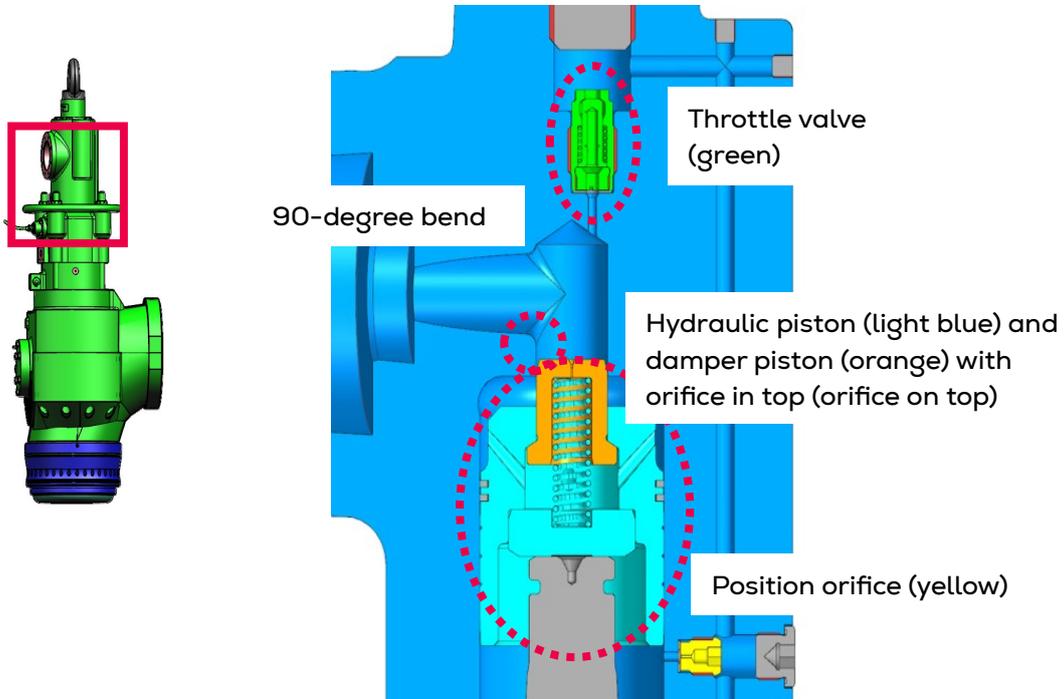
Fig. 1: Critical components to inspect: 90-degree bend, throttle valve, hydraulic piston, orifice on top of damper piston, and position orifice

Item	Check	References
90-degree bore	Check inlet bore for cavitation	Figs. 1 and 2a
Throttle valve (below lifting eye)	<ul style="list-style-type: none"> - Check if oil level is above throttle valve - Inspect for metal particles around orifice and seating - Unscrew throttle valve and check movement - Disassemble throttle valve, verify if orifice hole is blocked by particles 	Figs. 1 and 2b
Position orifice	Verify whether orifice hole is blocked by particles	Figs. 1 and 2c
Hydraulic piston, damper piston, and orifice	<ul style="list-style-type: none"> - Dismantle piston from oil cylinder - Inspect oil cylinder bore for scuffing marks - Inspect the actuator piston for wear, scuffing, etc., including piston rings - Ensure that damper piston moves freely - Verify whether orifice hole in top of damper piston is free from particles 	Figs. 1 and 2d/2e

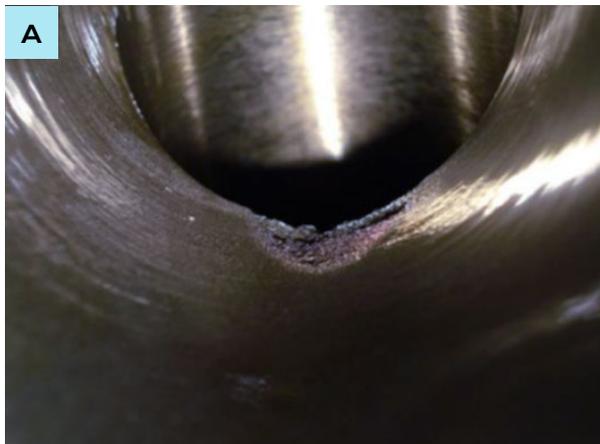
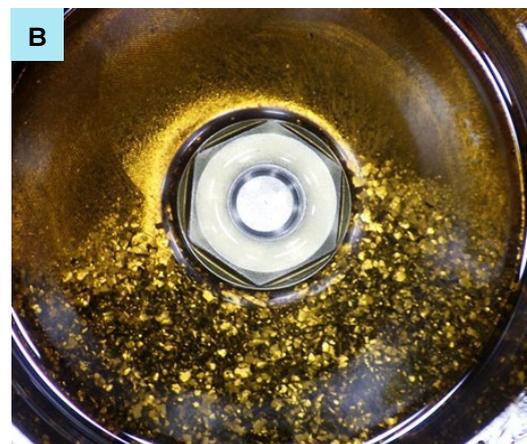
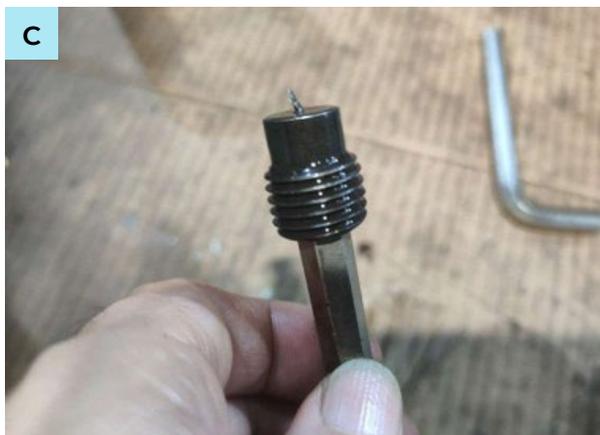
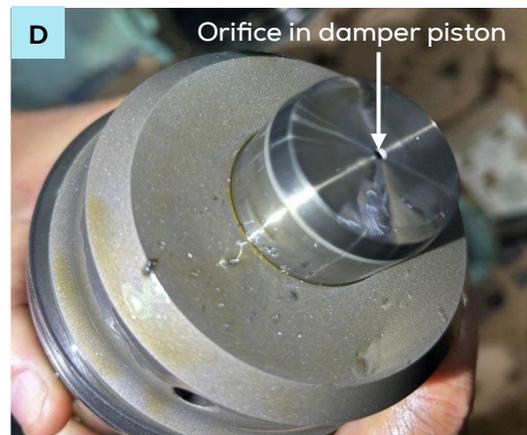
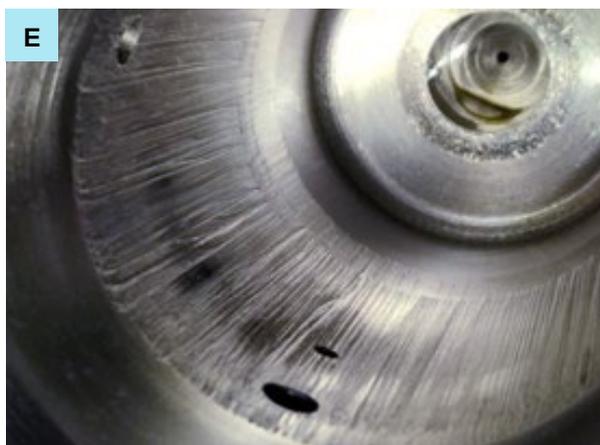
Fig. 2: Examples of a) Cavitation in 90-degree bend, and b) particles in throttle valve, c) clogged position orifice, d) particles in hydraulic piston and damper piston, and e) scratched oil cylinder

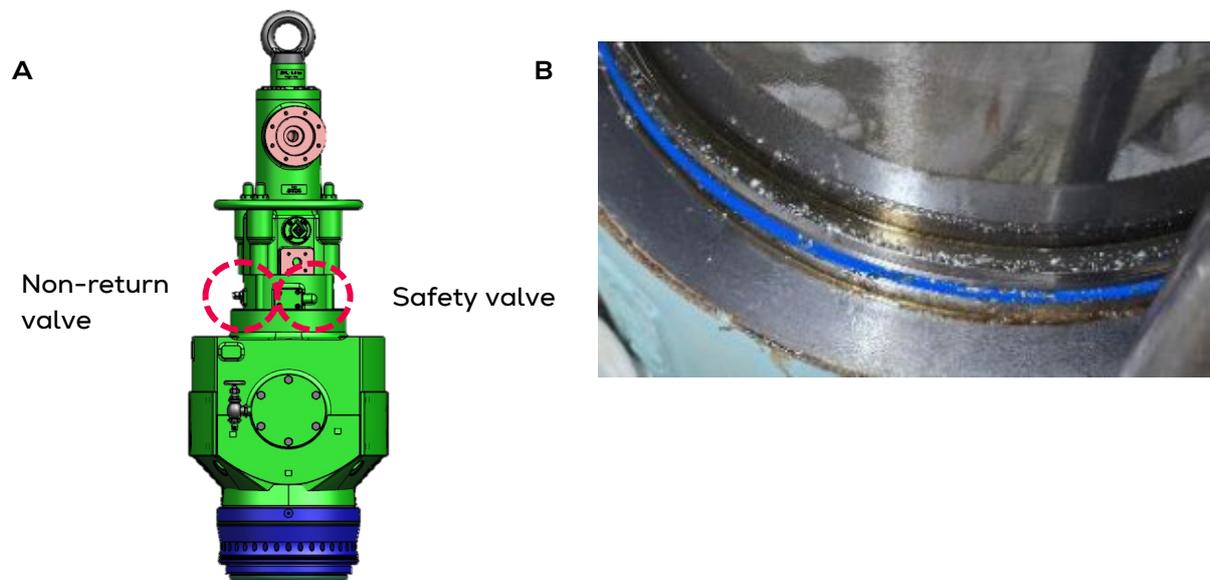
Fig. 3: a) Non-return valve and safety valve and b) Mating area between oil and air cylinders

Item or function	Check/adjust	References
Dropdown test	Tightness, seals	2265-0201 Work Card Appendix 1
Non-return valve	- Air inlet: 7 bar - Open/close function	Fig. 3a
Safety valve	Check setting according to manual. The XV3 exhaust valve is sensitive to incorrect settings.	Fig. 3a
Lift the oil cylinder	- Inspect for debris from cavitation - Check the condition of cylinder running surface	Fig. 3b (near O-ring) 2265-0201 Work Card

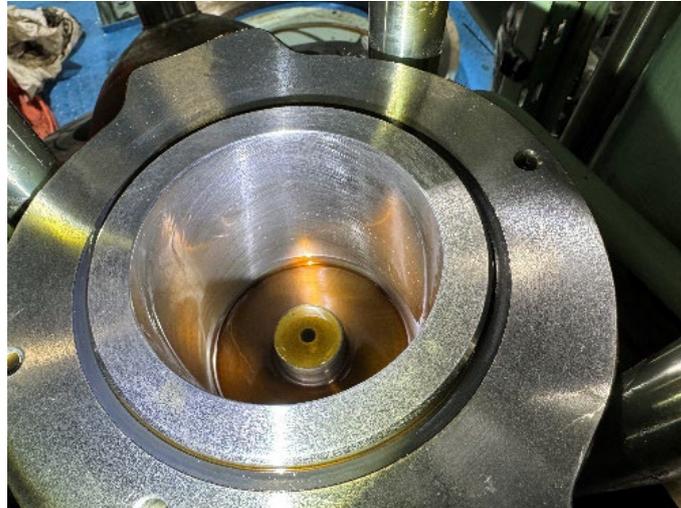
Fig. 4: Exhaust valve actuator housing

Items	Check	References
Exhaust actuator	- Inspect running surfaces of housing and step 2 piston, debris from cavitation can cause scuffing and scratches - Imprint marks may appear on the top cover; however, even if pronounced, they are considered purely cosmetic - For <u>normal</u> exhaust valve stroke, remove only top cover for actuator inspection. <u>Do not remove pistons, even if scratch marks are found</u> – a well-running actuator will continue to run if scratch marks stay aligned - For <u>reduced</u> exhaust valve stroke, dismantle pistons and recondition running surfaces by slightly grinding the surface	- 4565-0101 Work Card - Fig. 4 - Appendix 1

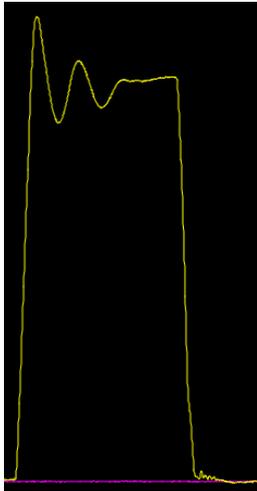
Fig. 7: Air trapped in top of oil cylinder
Throttle valve and position orifice completely blocked by small metal debris, spindle bouncer in open position, reduced opening stroke, closing damper disturbed.

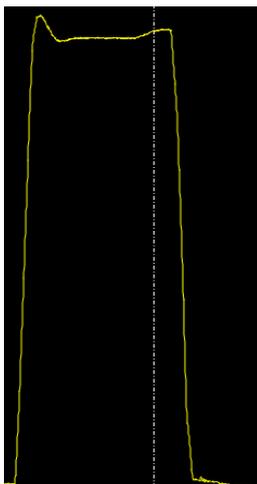
Fig. 8: Air trapped in top of oil cylinder
Throttle valve or position orifice partly blocked by metal debris.

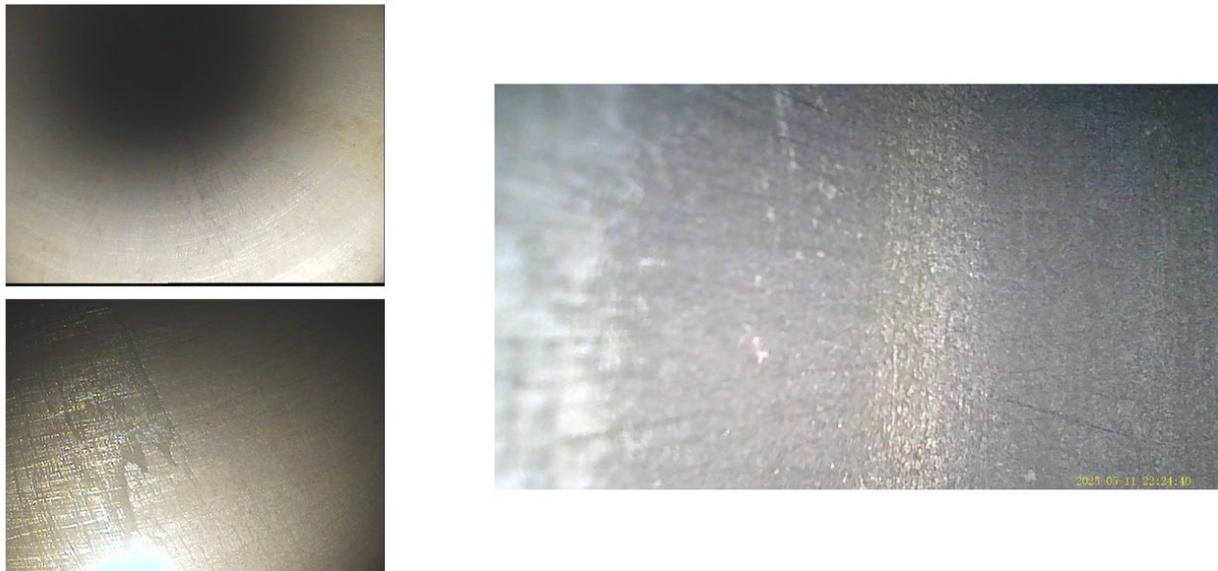
Stage 2 cavitation

Fig. 10: Changes in the surface that are defined as light cavitation, or alterations to the surface

Stage 1	No cavitation - Accepted for unlimited use
Stage 2	Changes in surface defined as light cavitation or alterations to surface - Depth of cavitation evaluated to less than 1 mm - Reinspect pipe frequently - Can be accepted for unlimited use
Stage 3	Slight to medium cavitation - Depth of cavitation evaluated to between 1 mm and 3 mm - Reinspect pipe frequently - Can be used within a limited period of 2–6 months
Stage 4	Heavy cavitation - Depth of cavitation evaluated to be more than 3 mm - Exchange the pipe

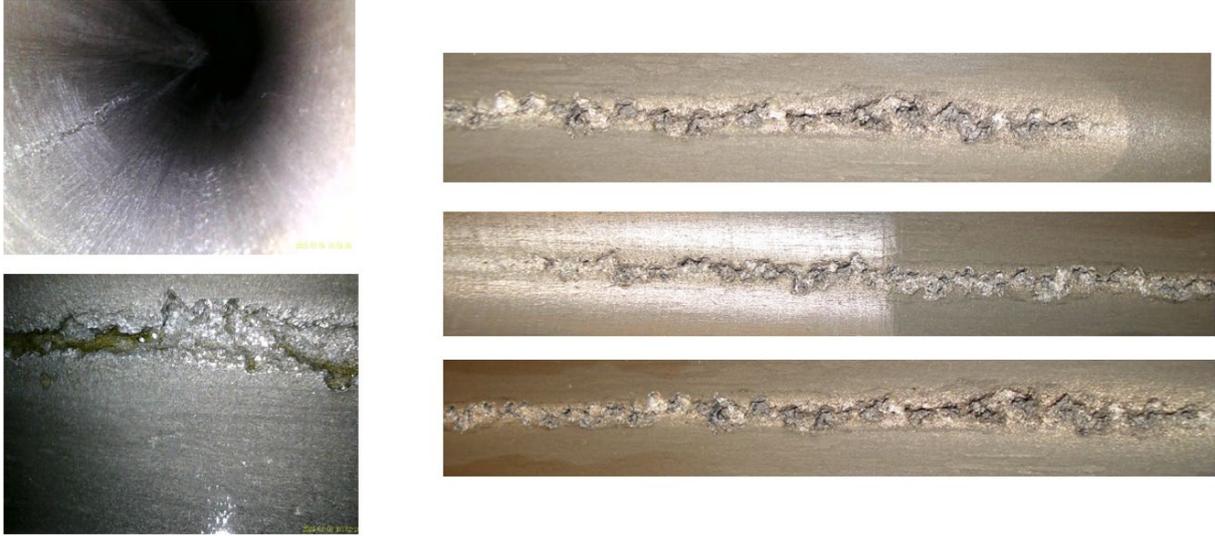
Stage 3 cavitation

Fig. 11: Slight to medium cavitation

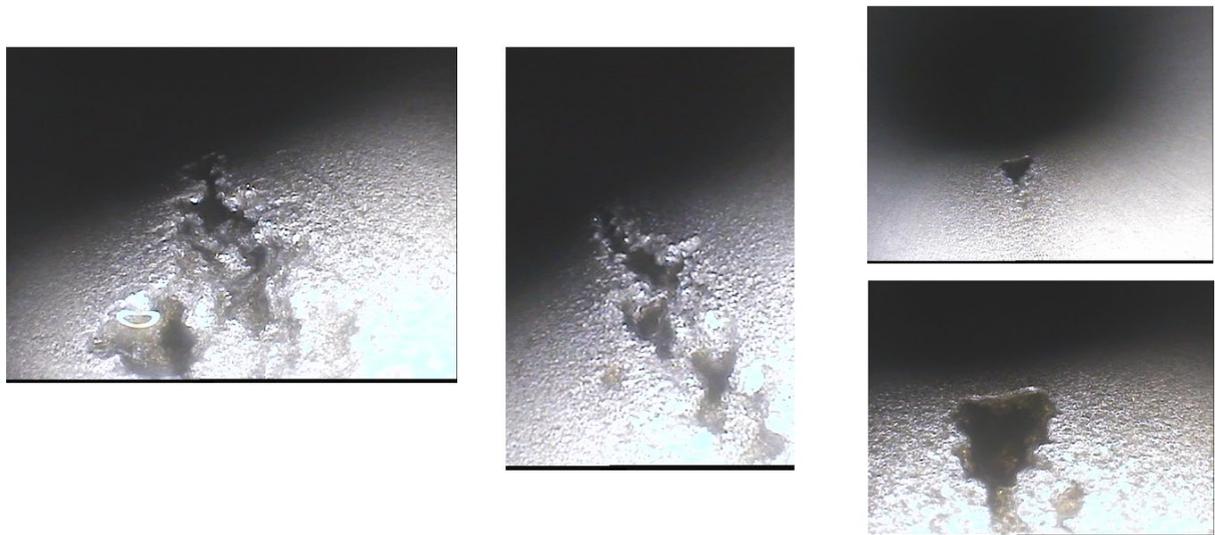
Stage 4 cavitation

Fig. 12: Heavy cavitation
