Two-stroke

Tightening of hydraulic high-pressure pipe

Update of procedure

Owners and operators of Everllence B&W two-stroke marine combustion engines.
Engine types: 10.6 and LGIM engines

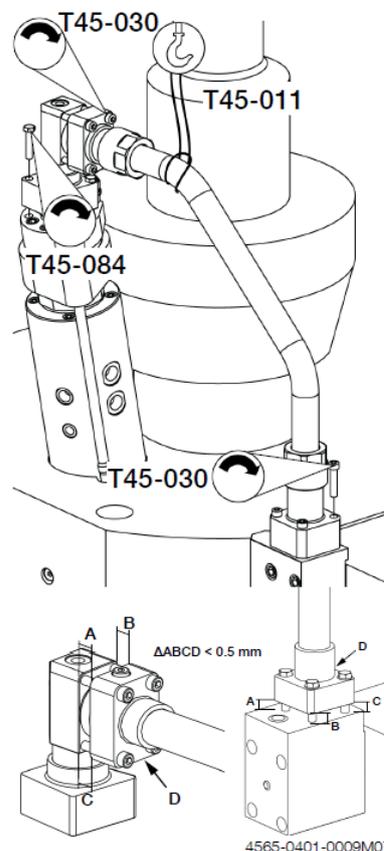
Fig. 2: Extract from 4265-2051-0020 Work card – Arrangement of second fuel control pipes

We have been informed about an incident where hydraulic oil leaking from the hydraulic high-pressure pipe sprayed onto a hot surface and caused a minor engine fire. Such an incident poses a potential danger to persons and property and can lead to personal injuries or, in the worst case, even fatal accidents.

Our investigation into the subject identified the importance of applying the correct mounting procedure and the correct tightening sequence.

As a countermeasure, we have updated our tightening instruction which must be used in future. Fig. 2 shows the updated section in the instruction manual.

NOTICE All screws MUST be cross-tightened in steps and with attention to parallel assembly within max. 0.5 mm of difference at each flange corner.

Mount and tighten the screws at all three flanges of the hydraulic high-pressure pipe and FBIV by hand.

Tighten in the following sequence :

1. Lower pipe flange, step 1
2. Upper pipe flange, step 1
3. FBIV flange, step 1
4. Lower pipe flange, step 2
5. Upper pipe flange, step 2
6. FBIV flange, step 2
7. Lower pipe flange, step 3
8. Upper pipe flange, step 3
9. FBIV flange, step 3

For tightening torque of each step, see the data.
