Four-stroke Small bore

April 2026

Action code: WHEN CONVENIENT

Wear on piston skirts

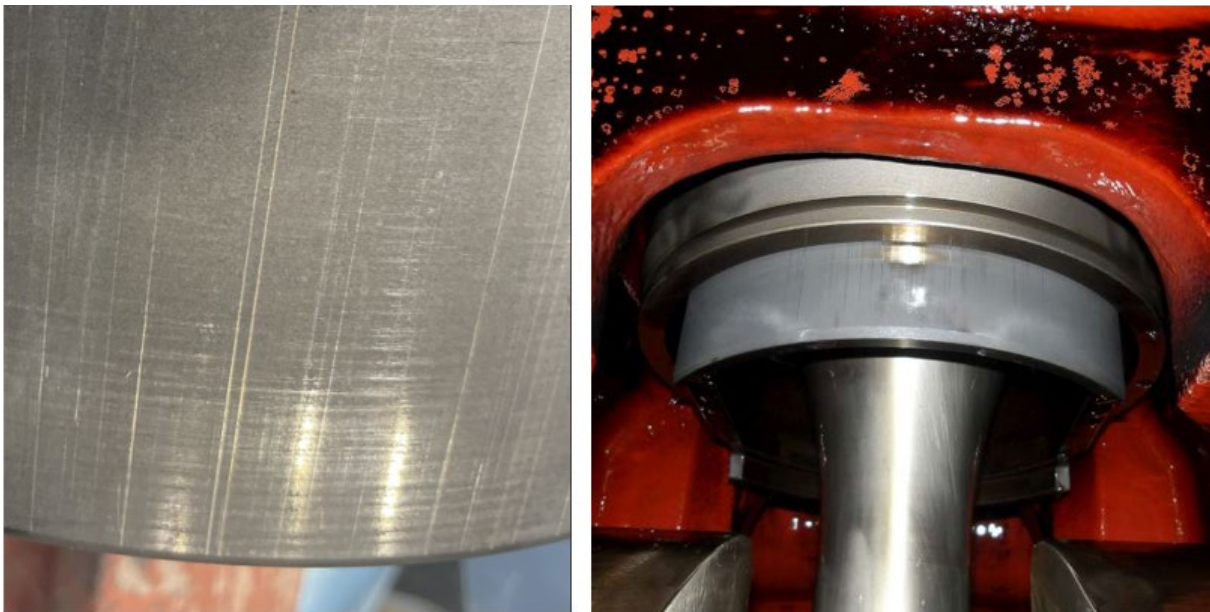
Wear and tear marks are mainly caused by combustion particles trapped between the piston skirt and the cylinder liner. These marks typically appear as:

- Single, fine longitudinal lines
- Minor polishing of the surface

Such marks are considered acceptable and are not a cause for concern, provided they remain limited in severity and do not progress into deep scoring or surface damage.

Fig. 1-2: Wear and tear marks on the piston skirt – acceptable for reuse.
