Four-stroke Small bore

April 2026

### Action code: WHEN CONVENIENT

## Wear on piston skirts

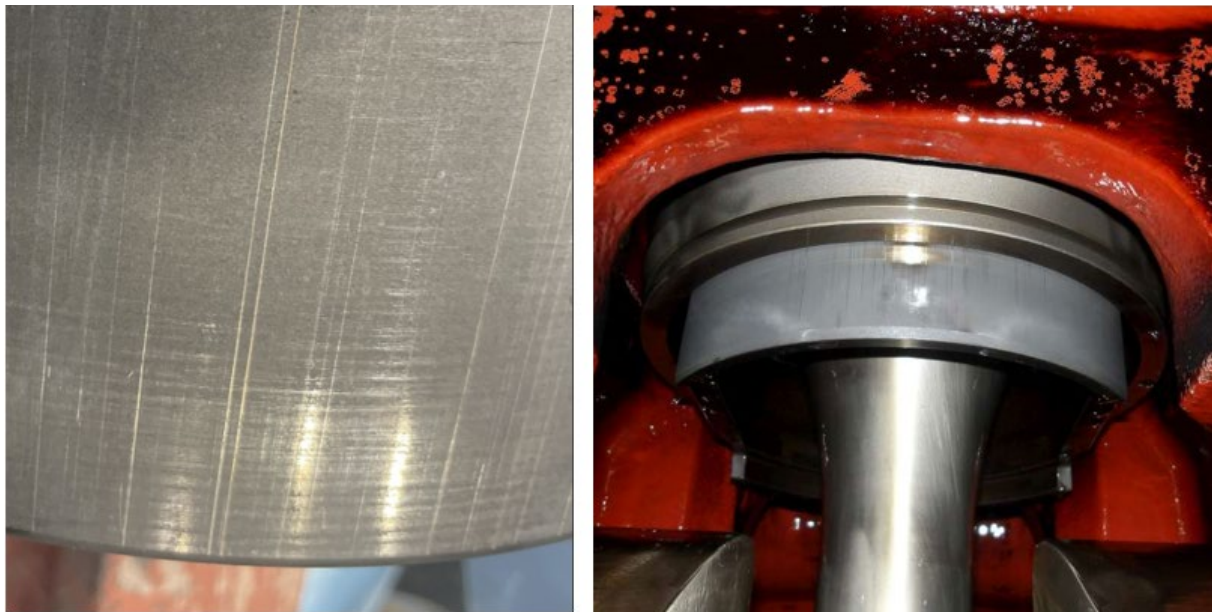
Wear and tear marks are mainly caused by combustion particles trapped between the piston skirt and the cylinder liner. These marks typically appear as:

- Single, fine longitudinal lines
- Minor polishing of the surface

Such marks are considered acceptable and are not a cause for concern, provided they remain limited in severity and do not progress into deep scoring or surface damage.

*Fig. 1-2: Wear and tear marks on the piston skirt – acceptable for reuse.*

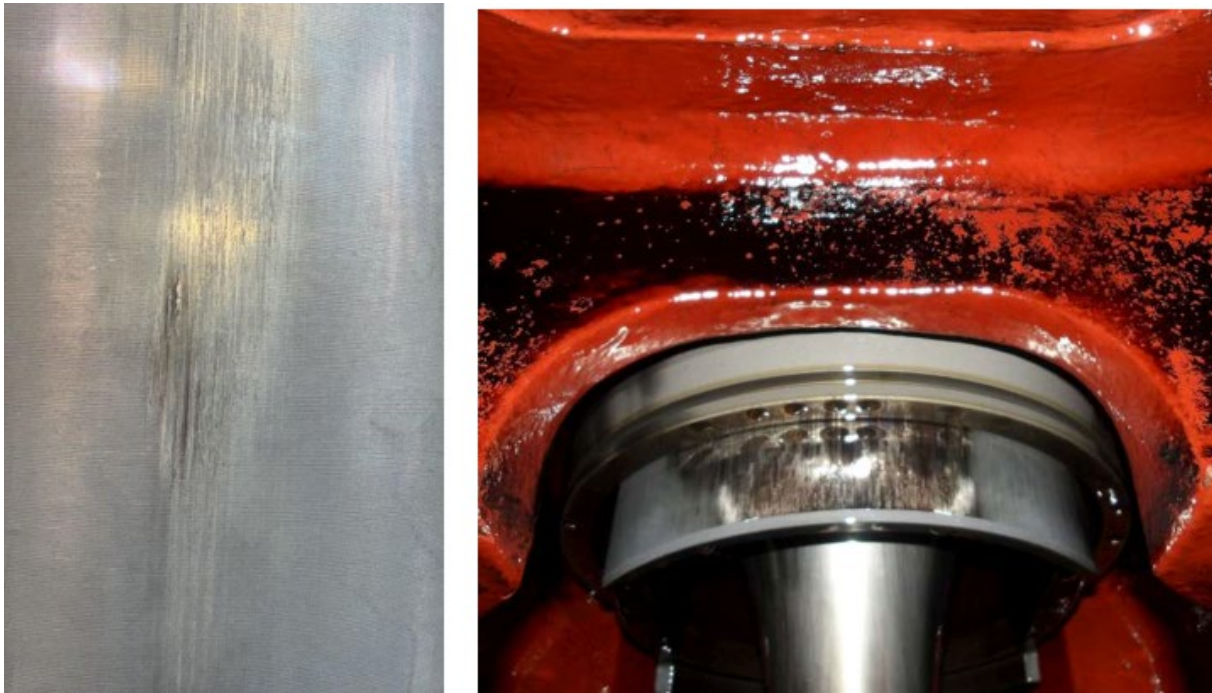
Seizure marks on the piston skirt are a clear indication of abnormal friction and overheating between the piston and the cylinder liner. In the case of seizure, the following characteristics are typically observed:

- Breakdown of the phosphate coating on the piston skirt
- Significant increase in surface roughness
- Signs of localized welding between piston and liner
- Torn or ripped-off material on the skirt surface

*Fig. 3-4: Seizure marks on the piston skirt – replacement of the skirt is required.*

The root causes of seizure marks can generally be categorized into lubrication, temperature, and combustion-related issues. The examples below are representative but not exhaustive.

- Incorrect lubricating oil type or SAE viscosity grade
- Lubricating oil temperature too high or too low
- High contamination levels in the lubricating oil

- Excessively high cooling water temperature
- Insufficient cooling oil supply to the piston
- Engine overload
- High engine load applied to a cold engine without proper pre-lubrication and preheating

- Poor fuel injection resulting in high soot formation
- Incorrect injection timing causing engine knocking

When seizure marks are present, the piston skirt must be replaced, as the material properties and surface treatment are no longer adequate for continued operation.

If scoring marks are observed on the piston skirt, the cylinder liner must be replaced or re-honed, where applicable, before installing a piston with a new skirt. Failure to restore an acceptable liner surface condition will lead to rapid recurrence of damage.
