Two-stroke

Copenhagen, July 2026

## ME Engine Control System Software version 1909-15 (MPC) Identified issues potentially affecting engine operation

Owners and operators of Everllence B&W two-stroke marine combustion engines  
Types: ME-engines with software version ME-ECS-SW-1909-15

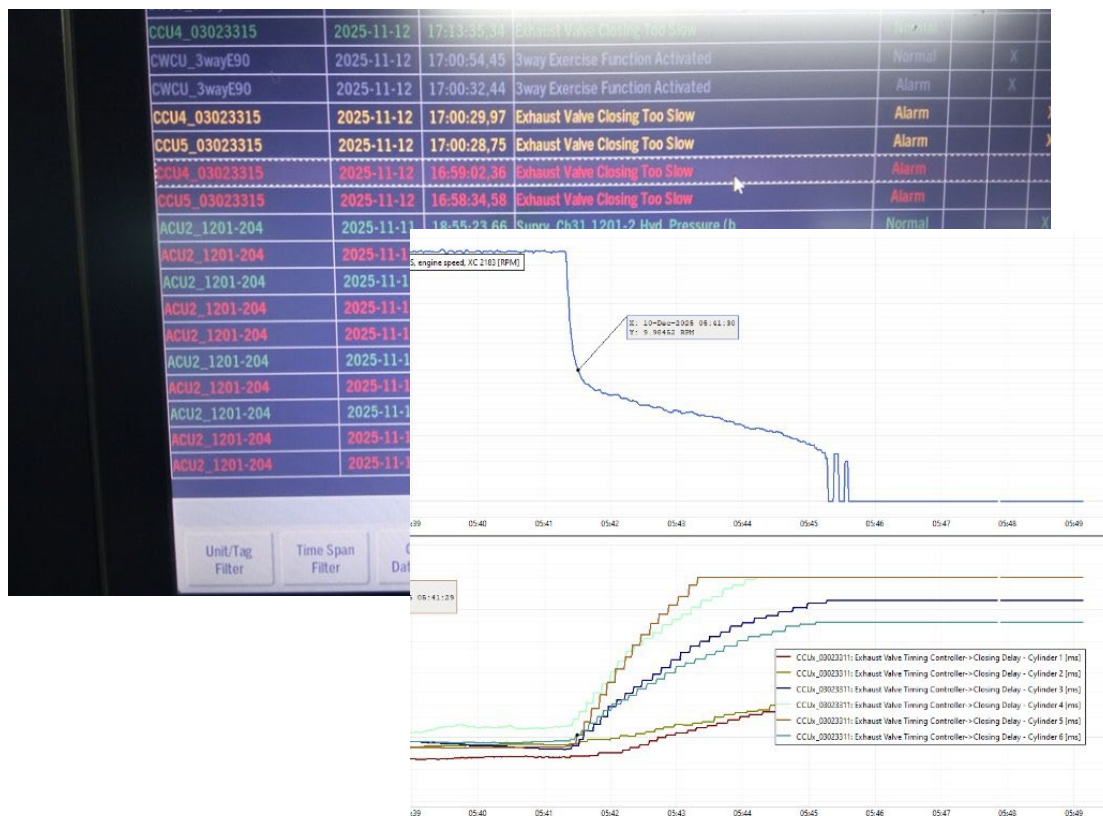
Internal issue ID: ECS-7902

### False 'Exhaust Valve Closing Too Slow' alarm

A weakness in the exhaust valve supervision algorithm may cause false alarms of this type to be emitted when the engine is running at speeds below dead-slow, e.g. during windmilling.

At low engine speed, the supervision algorithm has a tendency to over-estimate the exhaust valve close delay, depending on the shape of the measured exhaust valve position signal. This over-estimation leads the system's delay compensation function to reach its positive adjustment limit, which causes the alarm to be raised.

The defect will be resolved by a new software that reduces the likelihood of delay over-estimation and automatically cuts out the alarm when the engine speed is below dead-slow.

We recommend that if alarms of this type occur, while the engine is running at speeds below dead slow, they be acknowledged and no further action taken.

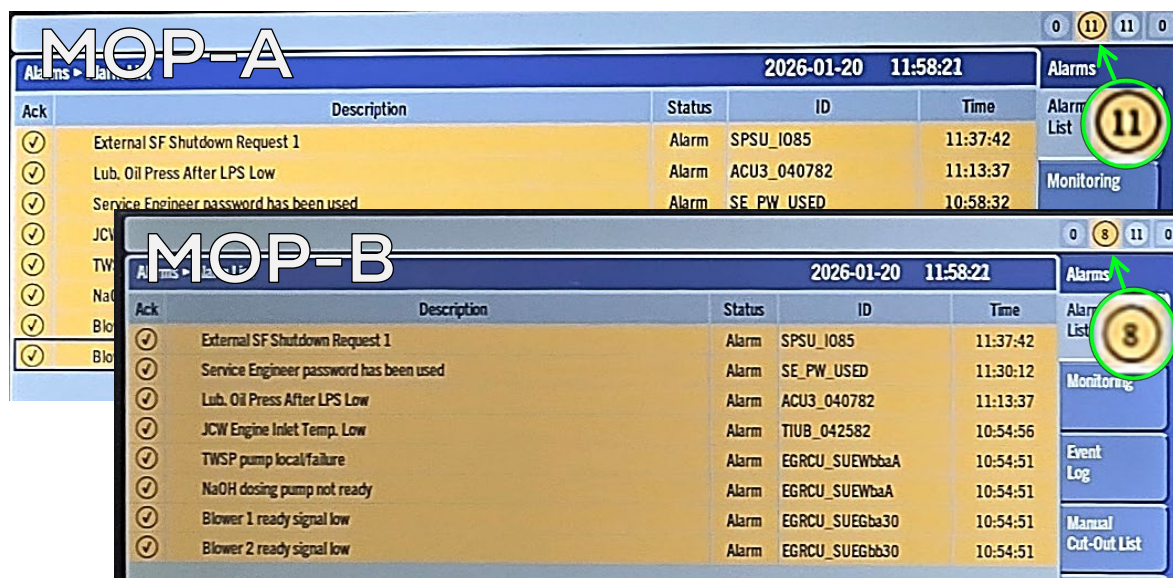
Internal issue ID: HMI-1097

### MOP active alarm count inconsistency

The active alarm count values displayed in the yellow-circle field in the upper-right corner of the MOP units may over time become inconsistent, because the counter value is not properly decremented when grouped alarms are cleared.

The alarm grouping function is running completely independently on the two MOP units, but small timing deviations may cause them to react differently to alarm events in ECS because of this defect. This is why the two MOP units may arrive at different alarm count values although they are running the exact same software.

The underlying defect has been fixed in the latest software for Triton-based systems, and a similar fix will be implemented in the next release for MPC-based systems.

We recommend that operators do not use this field for determining whether there are active alarms. Operators should instead ensure that the 'Alarms'-'>'Alarm List' screen active on at least one of the MOP units at any given time.

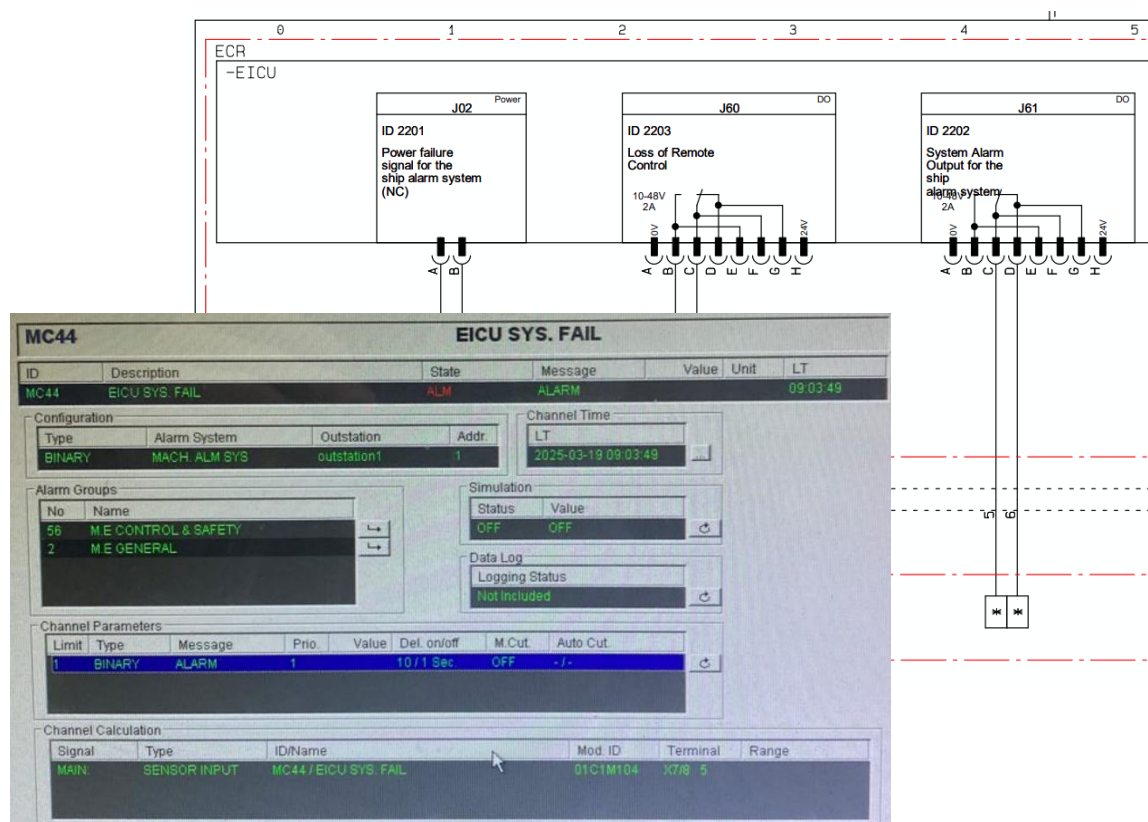
Internal issue ID: BES-12859

### Common alarm relay toggling without active alarm

The common alarm output relay J61 on the EICU units can get into a state in which it toggles even if there are no unacknowledged alarm channels in the system.

We are still working to re-create the problem in the laboratory, and the underlying defect has not yet been identified. But, we still believe to be able to provide a fix in the next software release.

If this situation should arise, we recommend that both EICU units be power-cycled at the earliest convenience with engine stopped. If that does not resolve the issue, then we recommend that all MPC units be power-cycled with the engine in Finished With Engine (FWE). If this latter action does not help, please contact us.

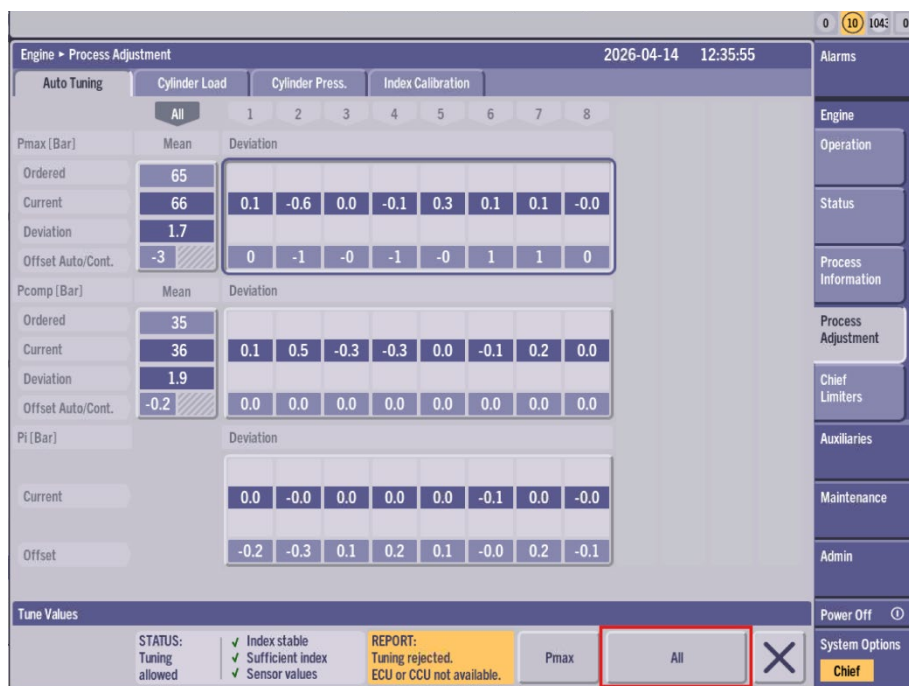
Internal issue ID: ECS-8635

### Auto Tuning Pi balancing rejected: ECU or CCU not available

For engines with Auto Tuning enabled, manual tuning of Pi on ECS-MOP screen Engine ->Process Adjustment->Auto Tuning will fail indicating 'Tuning rejected. ECU or CCU not available.'

The underlying software bug has been identified, indicating that this failure indication is most likely false. However, the bug does cause use of the 'All' button for Pmax and Pcomp key values to fail.

We recommend that operators avoid using the 'All' buttons but rather balance the individual combustion parameters separately by selecting the appropriate panel and clicking on the 'Pmax', 'Pcomp' and 'Pi' buttons in that order.

The operator should check the cylinder pressure adjustments shown in the Engine->Process Adjustment->Cylinder Press. screen to verify that: 1. The adjustment was successful, and 2. No individual cylinder adjustment has reached its upper or lower limit for adjustment.
