Two-stroke

### Action code: AT FIRST OPPORTUNITY

## Inspection of piston crown

- update of procedure

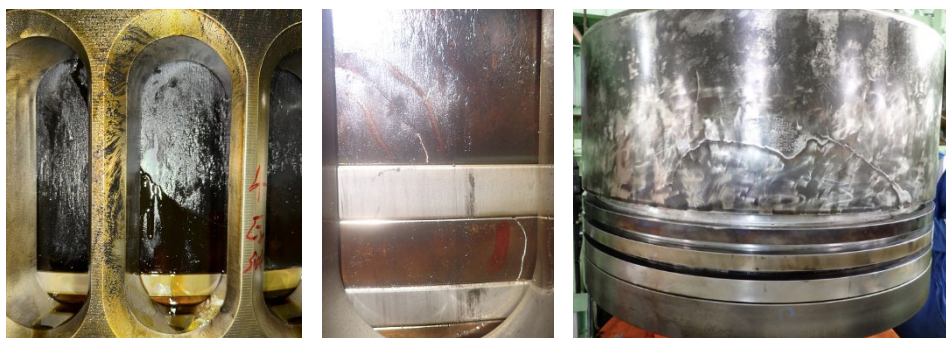
Fig. 1: Example of cracks in piston crowns as observed during scavenge port inspections with the oil pump running and after overhaul and cleaning

Everllence has experienced an increase in the number of reported cracks in piston crowns. In case a crack in the piston crown develops through to the outside of the crown, it may lead to system oil leaking through the crack. Furthermore, high-pressure and high-temperature combustion gas mixed into the piston cooling oil may flow into the crankcase and could potentially pose a risk of a crankcase explosion. Such an incident poses a potential danger to persons and property and can lead to personal injuries.

- Keep the cooling oil system running during scavenge port inspections.
- If a crown is cracked through to the outside, piston cooling oil will be visible flowing through the crack.
- If a crack leakage is detected, the piston must be replaced.

- When dismantling a piston, use the procedure applying additional slings that was released with SL2023-747.
- If detecting or suspecting a cracked piston crown, the piston crown must be replaced immediately. In case the vessel is at sea, emergency running mode 'case A' must be used until the next port, see instruction 6645-0320-XXXX Running with Cylinders or Turbochargers out of Operation. Inform Everllence [EngineSupport@everllence.com](mailto:EngineSupport@everllence.com) in case of emergency running and if observing cracks in piston crowns.

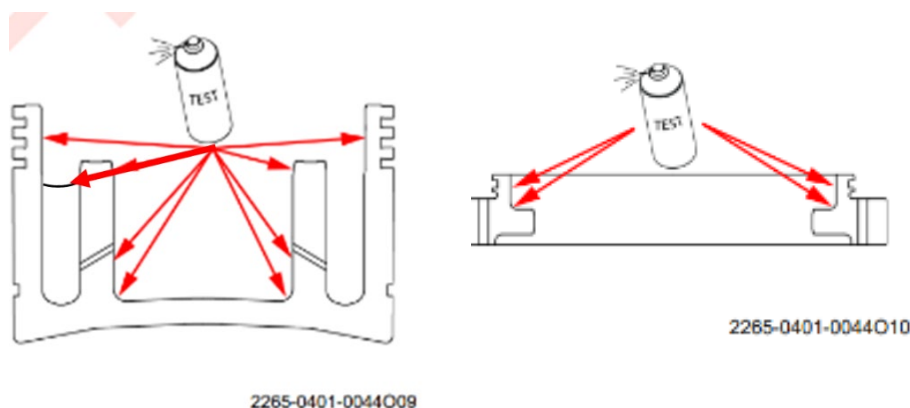
Fig. 2: NDT inspection according to instruction

- For all piston overhauls, the piston crown and piston skirt should be dismantled and a thorough NDT inspection of the piston crown, both inside and outside, should be conducted.
