Precision repair for Dresser-Rand barrel compressor

Advanced repair of compressor barrel bore

Steam turbine driven tail gas barrel compressor

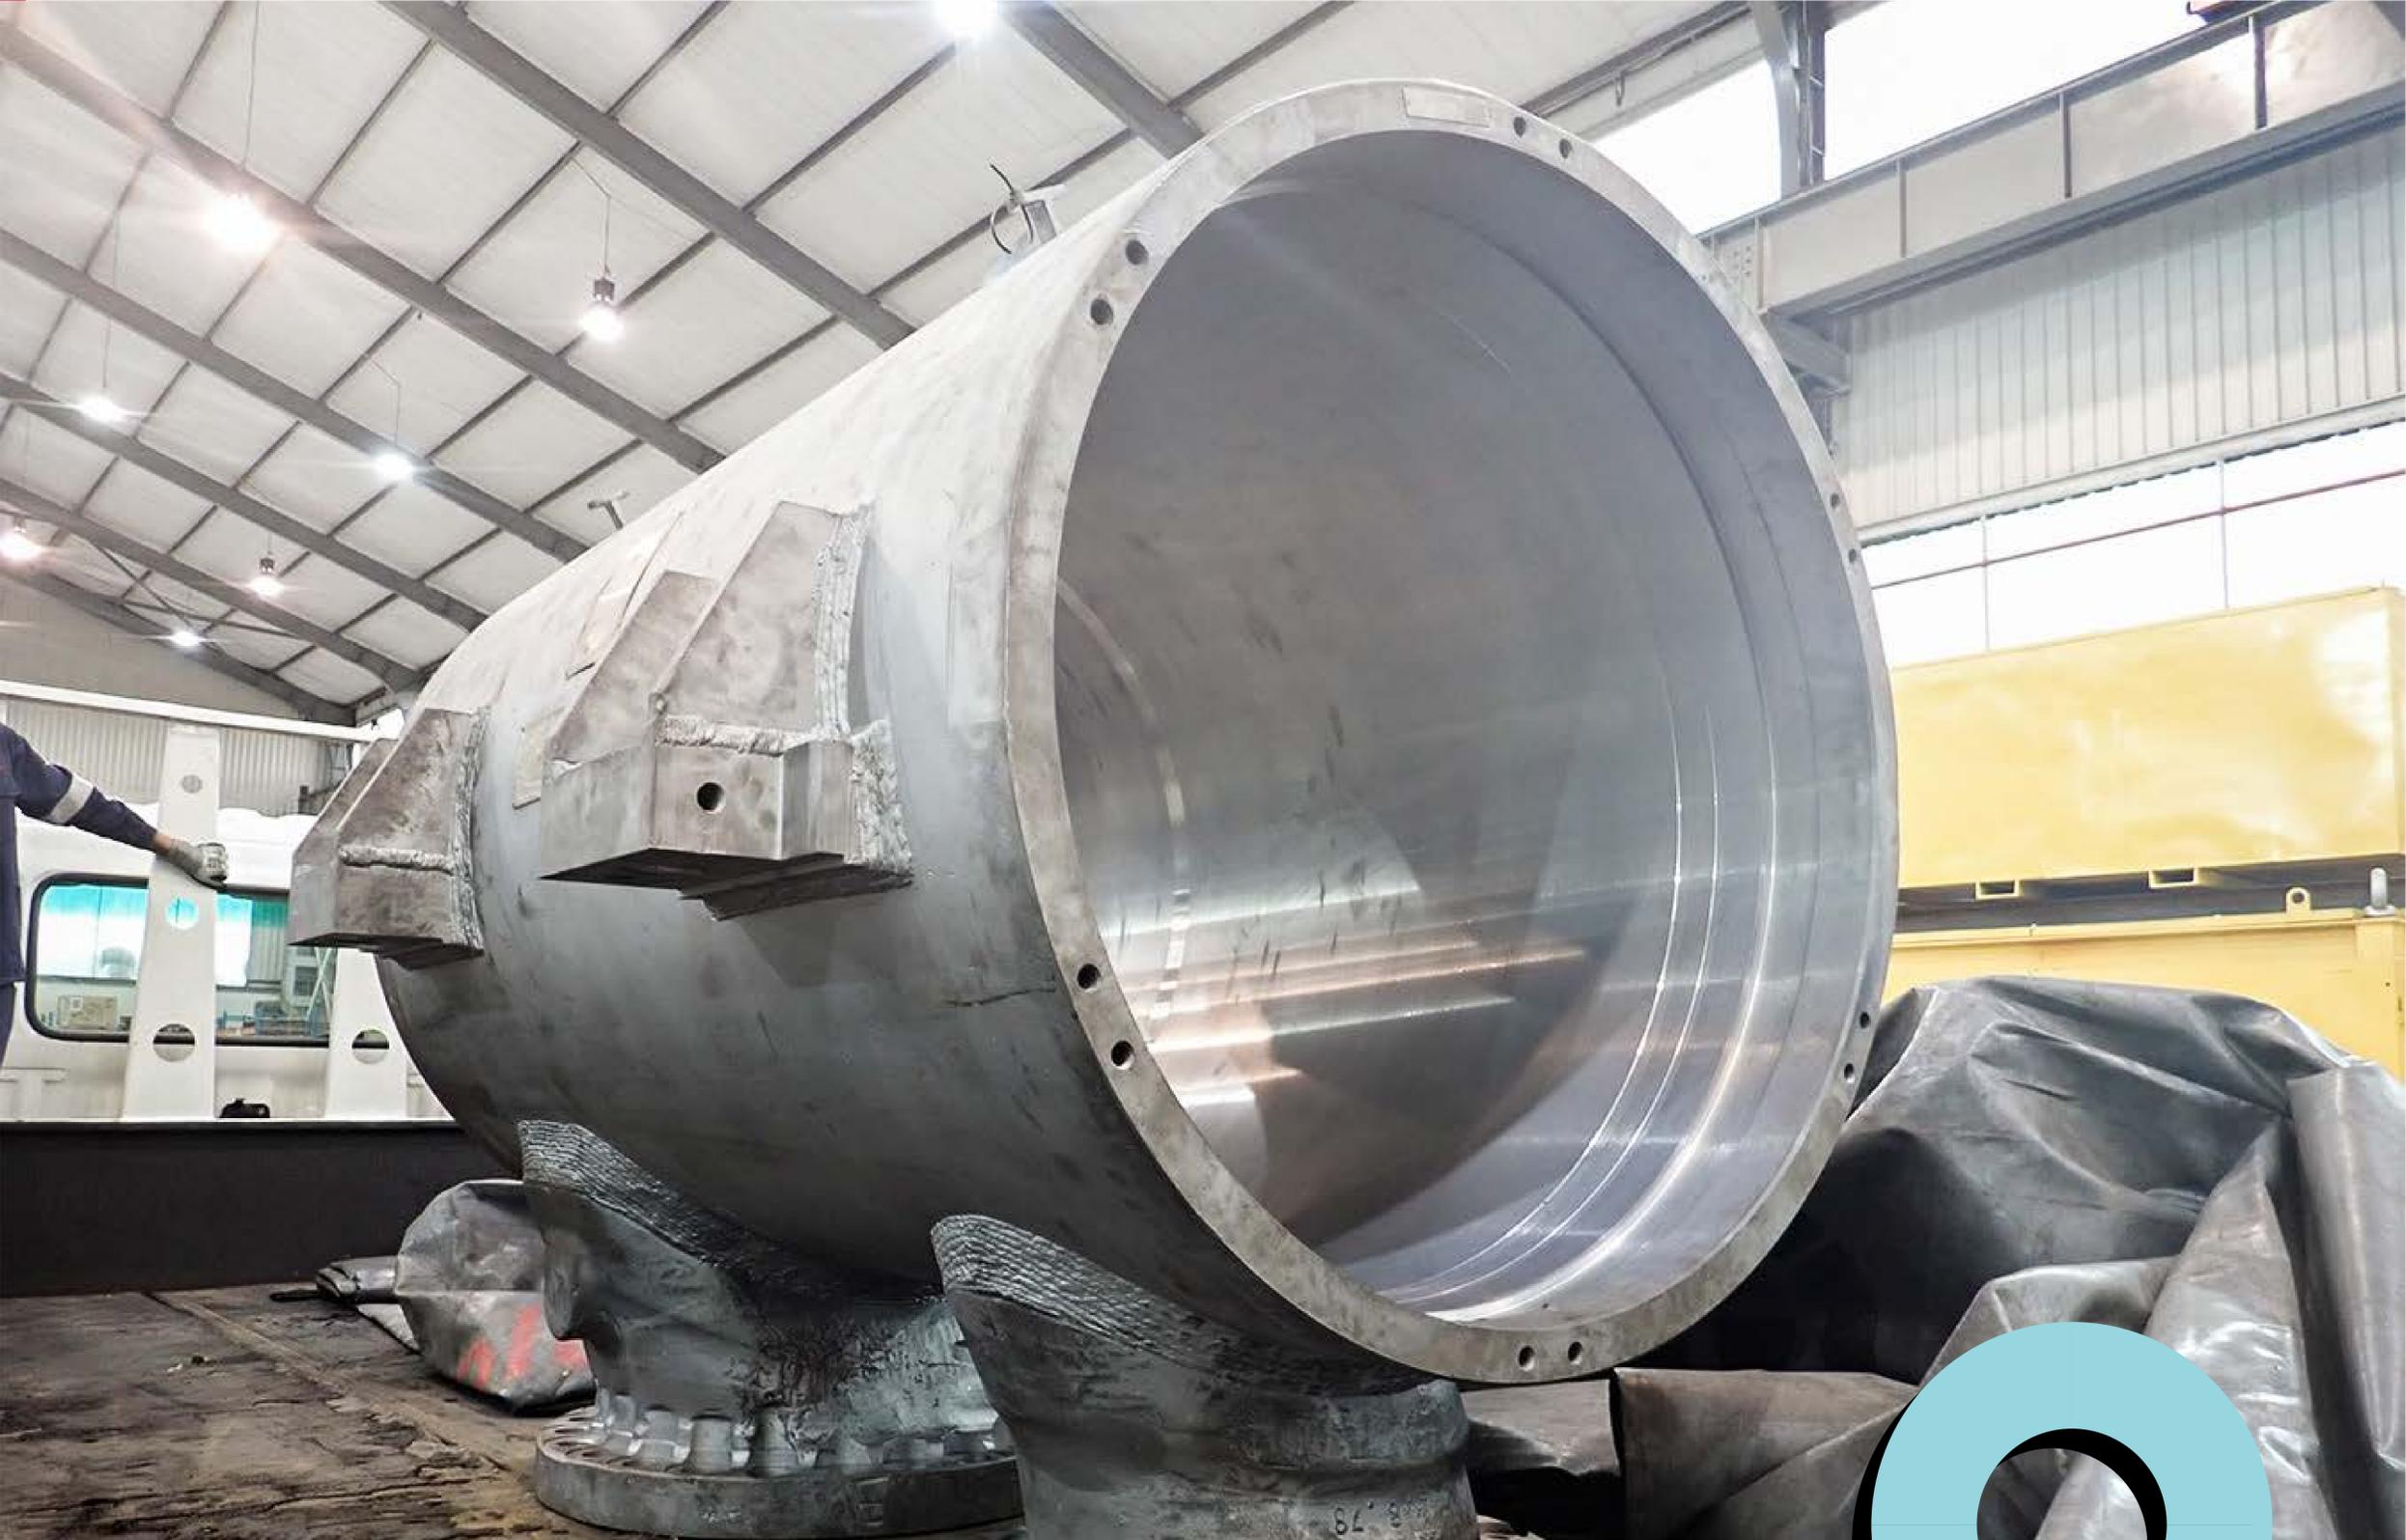
Cracks in casing and inlet nozzle, corrosion

- Casing pre-machining
- Laser welding of inner side of casing
- Final machining according to OEM specification
- Inlet and discharge nozzles (stainless cladded)

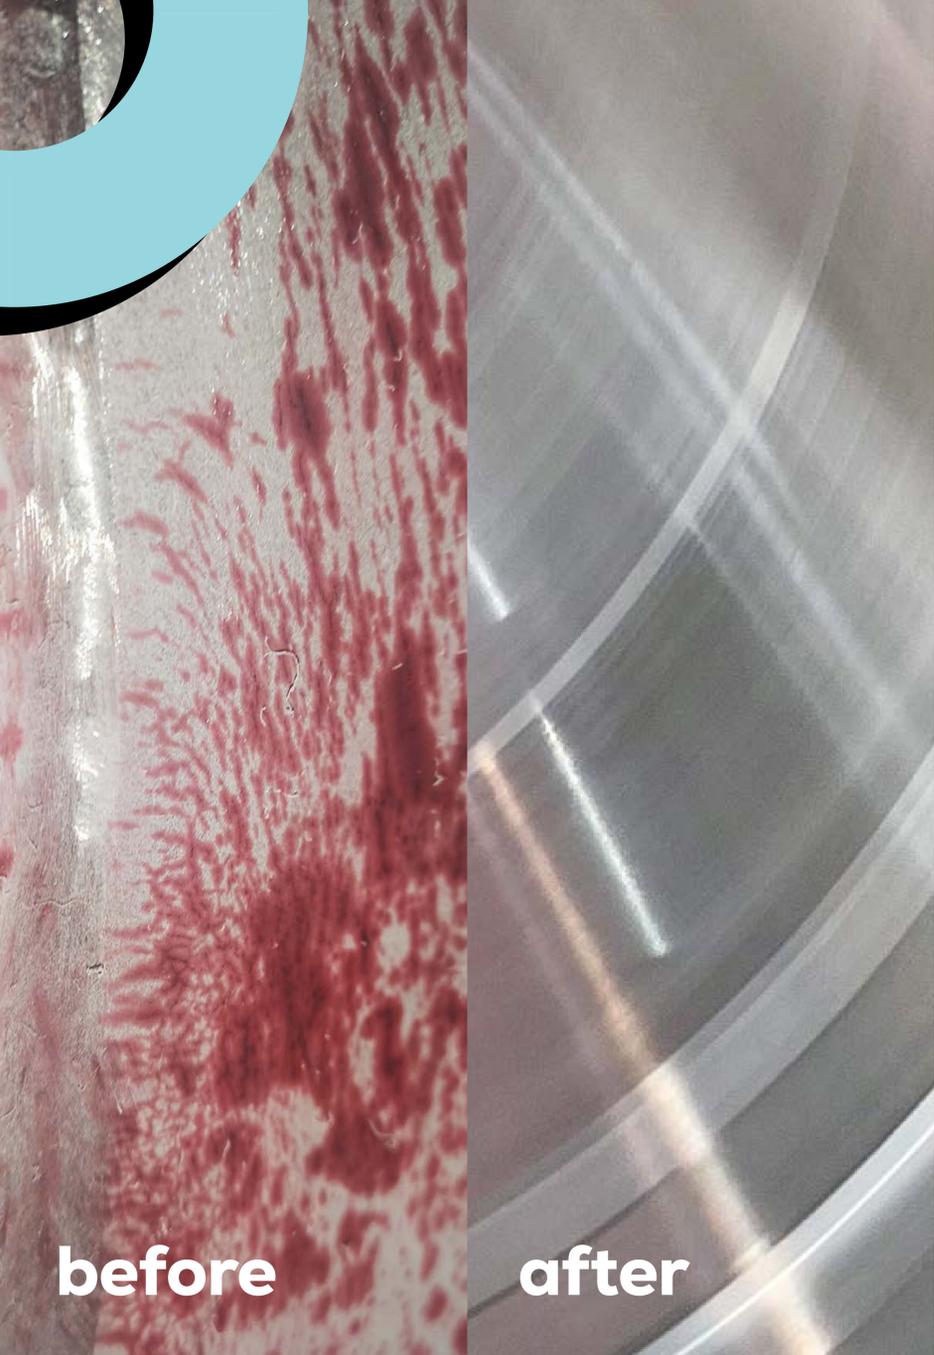
before

after
