Everllence B&W
two-stroke
marine engines

This paper describes the service experience gained from G60-, G70-, G80-, and G95-GI engine types.

Service experience for Everllence B&W ME-GI two-stroke engines

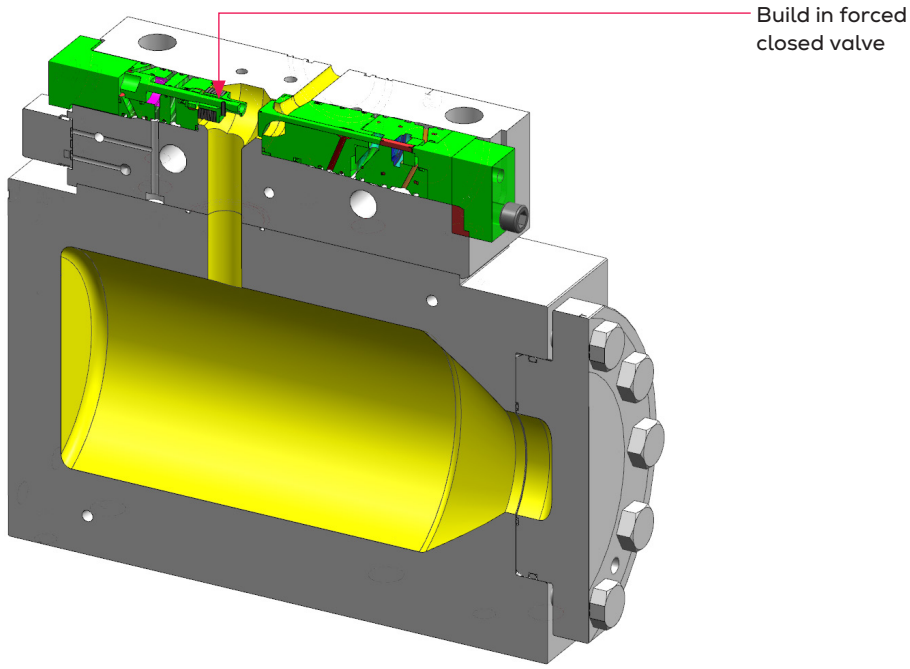
So-called connection pieces have been incorporated in the window valve design, eliminating the sealing issues encountered on the Mk. 1 design. However, initial issues with the new window valve design shown in Fig. 5 have been experienced in the Mk. 2 engine design.

Fig. 5: Window valve for Mk. 2 design

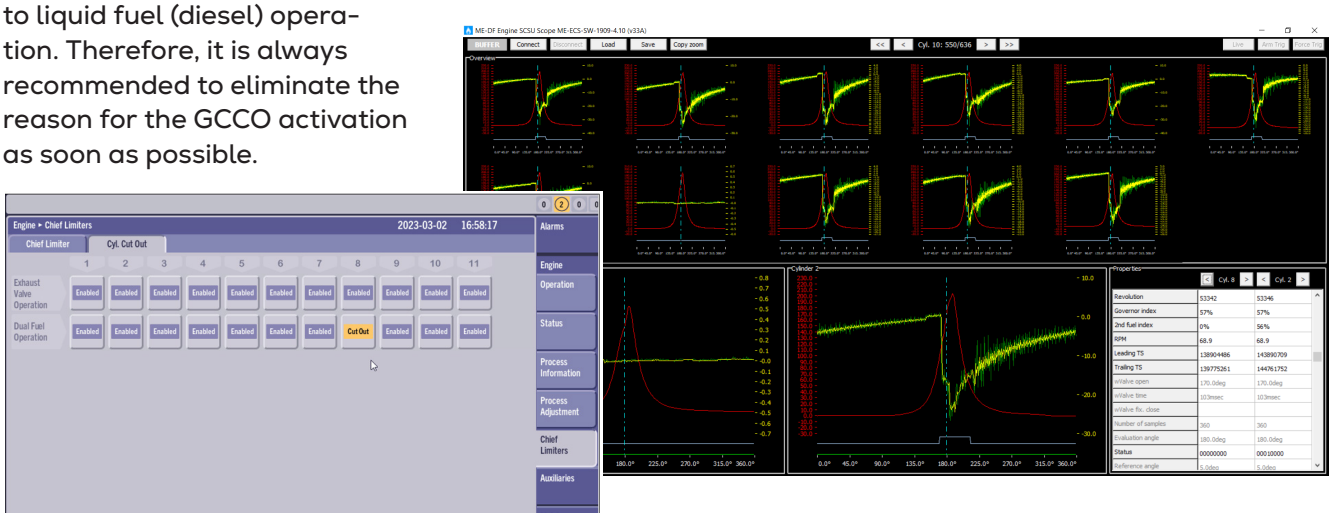
Fig. 9 shows the result of the GCCO service test, where cylinder No. 8 undergoes gas shutdown.

The gas channel pressure curves (green) in Fig. 9 indicate methane injection. The curves show that dual-fuel operation has ceased on cylinder No. 8, which continues in liquid fuel mode, while the remaining cylinders continue in dual-fuel mode. Only one cylinder at a time can be cut out with the GCCO function. If a second cylinder trips, the control system will switch the engine smoothly to liquid fuel (diesel) operation. Therefore, it is always recommended to eliminate the reason for the GCCO activation as soon as possible.

Fig. 9: Illustration of the principles behind the new gas cylinder cut-out feature

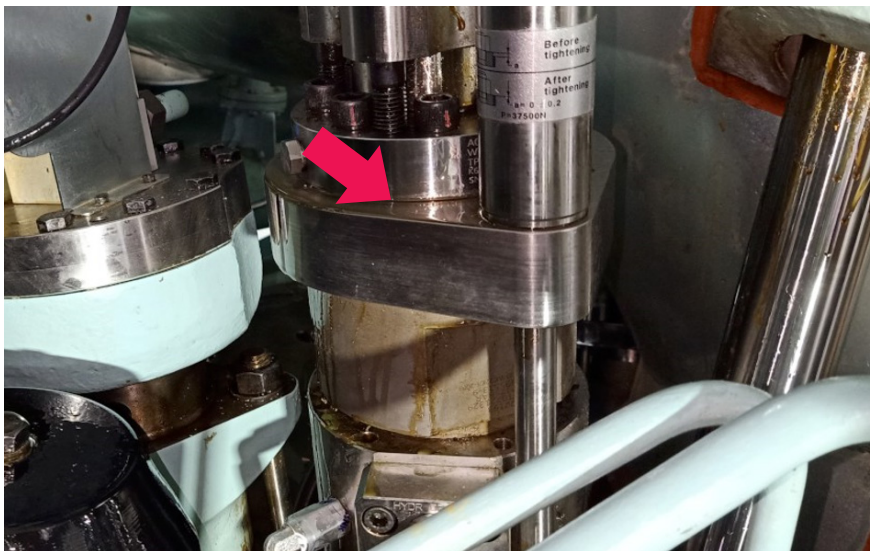
The top cover of the pilot booster injection valve (PBIV) has been observed leaking hydraulic oil from the top cover (Fig. 10), sometimes after only a few hundred running hours.

Leakage has been observed in most types of PBIV across various engine types. The root cause has been identified as the Viton O-ring in the top cover (Fig. 11), which becomes too soft and eventually disintegrates.

Fig. 10: Pilot oil and fuel booster injection valve (PBIV) top cover leakage

The solution has been to replace the Viton O-ring shown in Fig. 12a with the PU seal shown in Fig. 12b, which is equally easy to install as the original Viton O-ring.

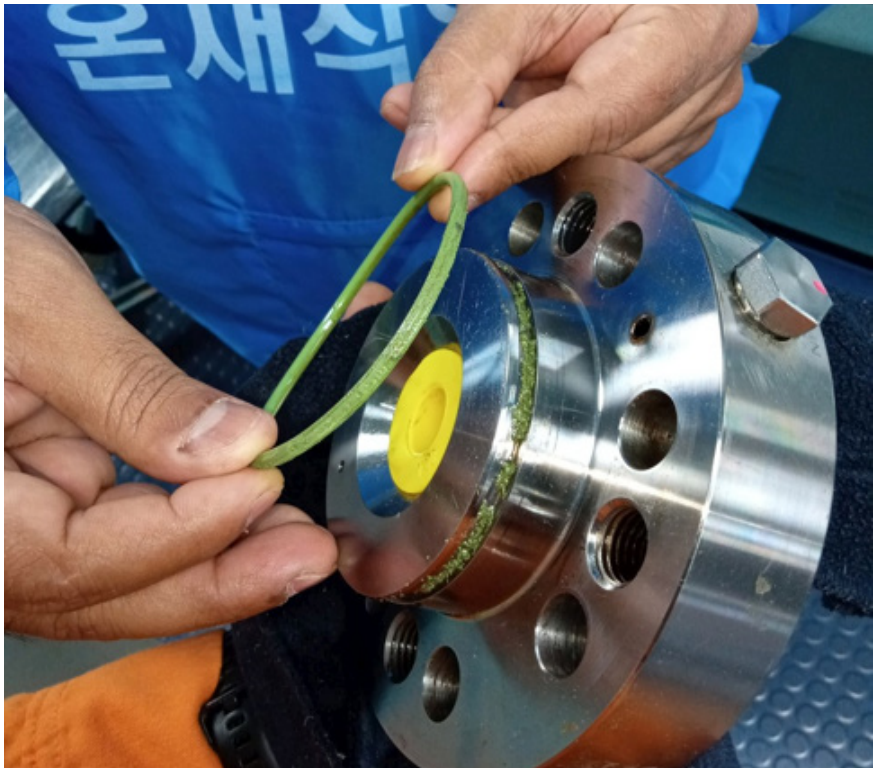
Fig. 11: Viton O-ring becomes too soft and disintegrates

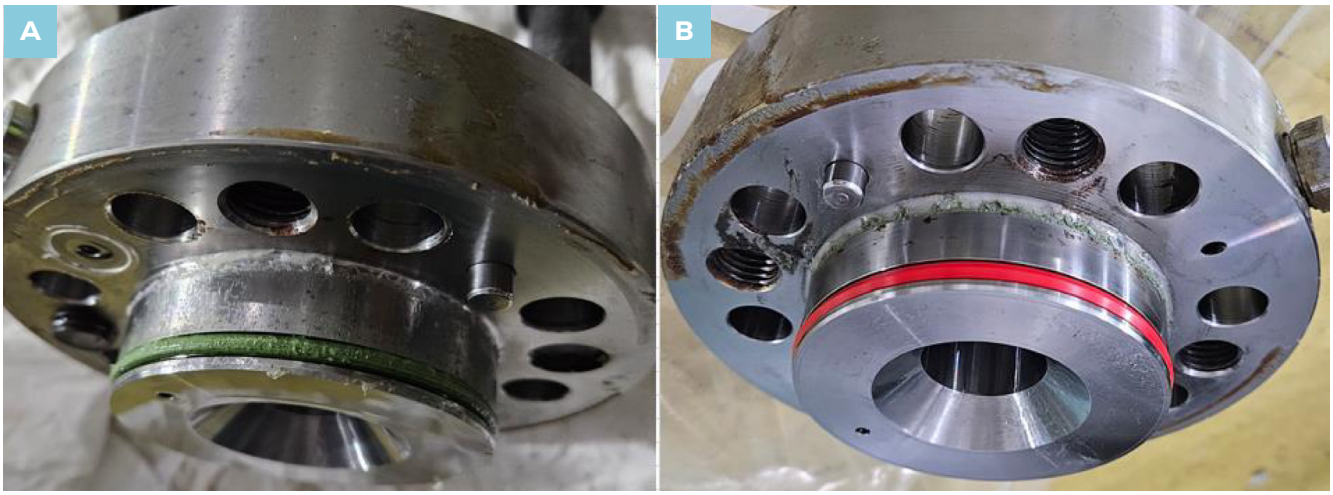
Fig. 12: The PU seal (b) has replaced the Viton O-ring (a), which caused leakage from the top cover

The new PU seal has resolved the leakage issue on the top cover of PBIV.

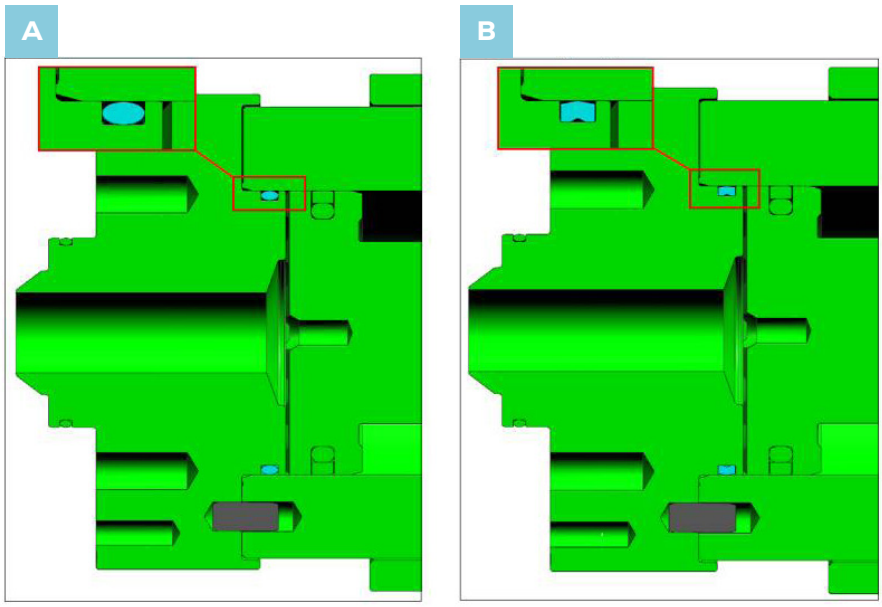
Fig. 13 compares the design of the old Viton O-ring (a) and the new PU seal (b).

Fig. 13: a) Old O-ring design versus b) new PU seal

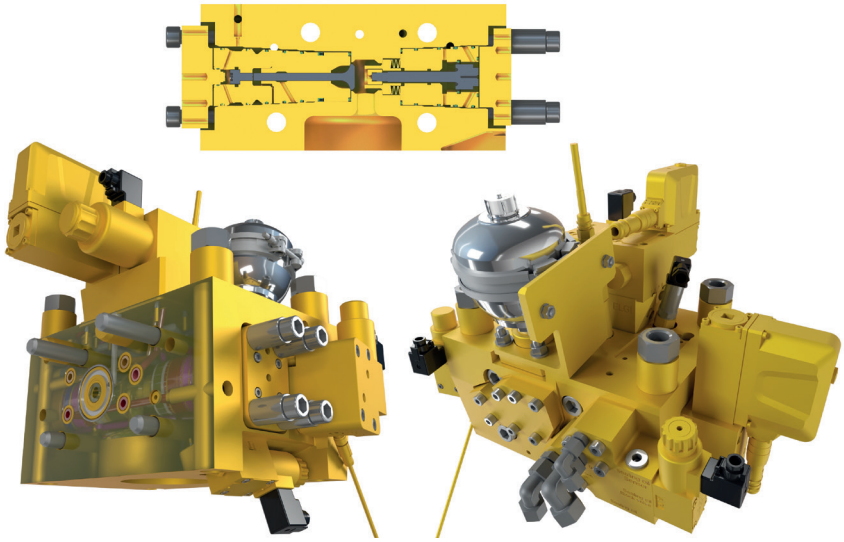
The ME-GI Mk. 2 gas block design has an integrated window valve arrangement, which consists of the window valve itself and a window valve 'forced close' (WVFC) part.
Fig. 14 shows the gas block with the window valve arrangement at the centre.

As shown in Fig. 15, when installing the first version of the WVFC, a Belleville spring could drop down and get wedged between the WVFC and the gas block.

Fig. 14: ME-GI Mk. 2 gas block with the window valve arrangement at the centre

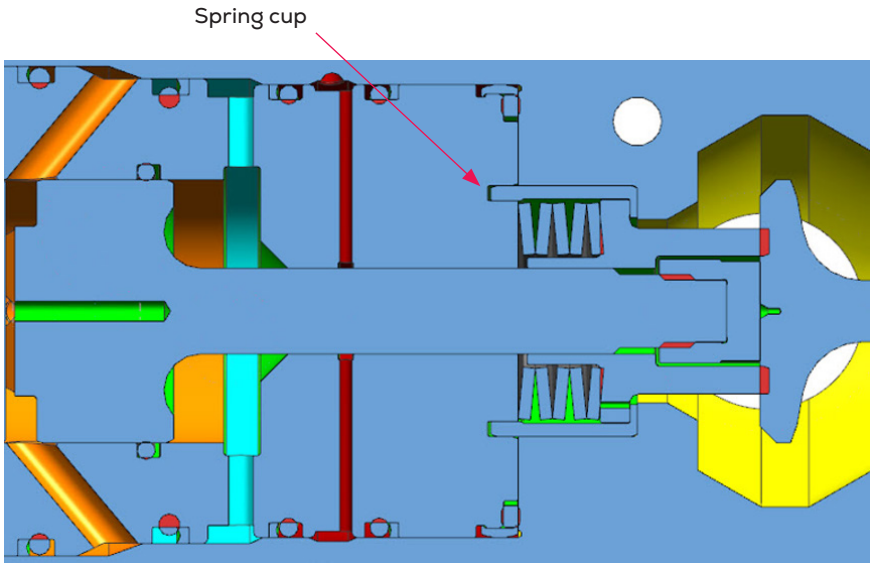
Fig. 16: Belleville spring could drop down and get wedged between the WVFC and the gas block

Fig. 16 shows the spring cup, which was introduced in a revision of the WVFC design, to prevent the spring in dropping down and getting wedged between the WVFC and the gas block.

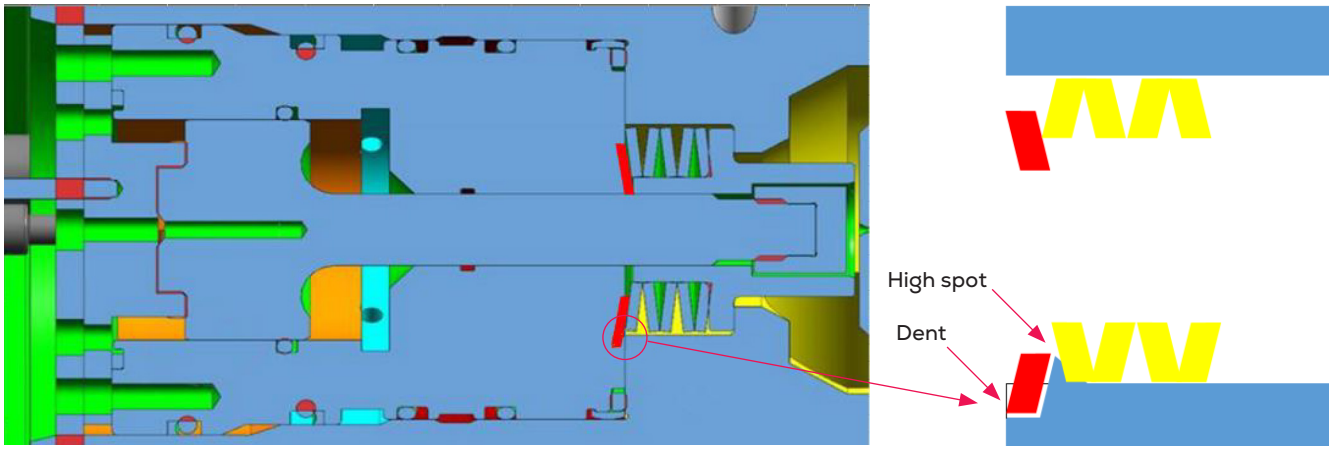
This design change has eliminated the risk of springs dropping down and the associated risk of gas block damage during WVFC assembly. Fig. 17 shows a schematic illustration of gas block damage because the Belleville spring had dropped down during the installation of the original WVFC design.

Fig. 17: Schematic illustration of gas block damage caused by the Belleville spring dropping down during installation of the original WVFC design

Updated instructions have been issued to guide the crew when mounting a WVFC of the original design.

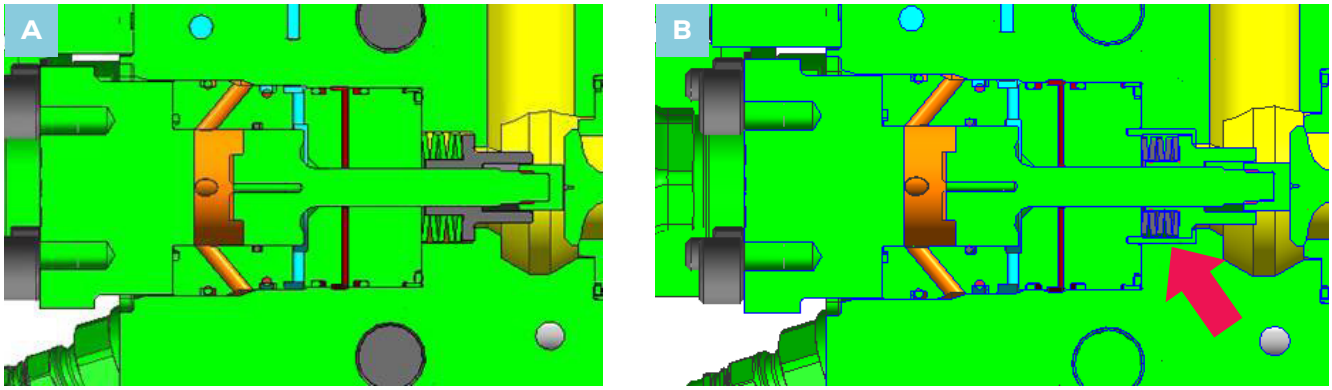
Fig. 18: Comparison of a) the original and b) the new WVFC design with a spring cup

Fig. 18 compares the original and the new WVFC design, which has been updated with a spring cup to prevent damage to the gas block.

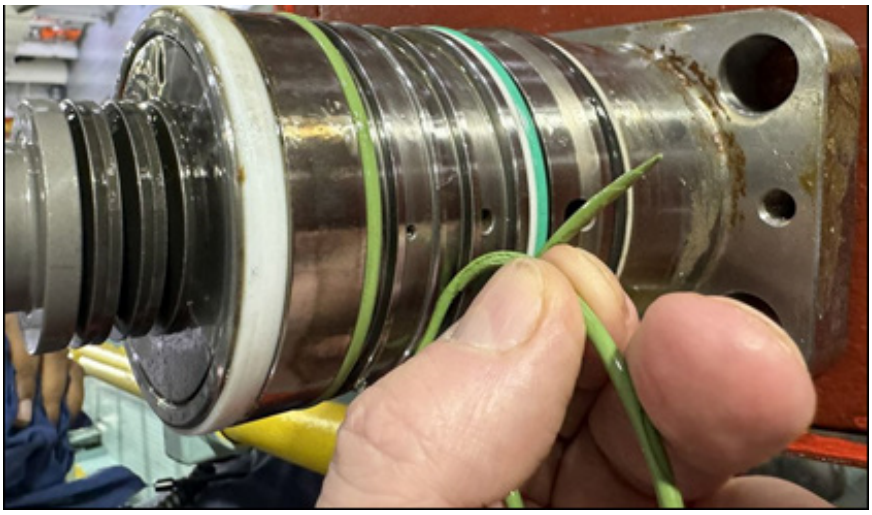
In the WVFC, O-rings kept breaking, leaking sealing oil internally to either the outer pipe or sealing oil return/drain lines. As Fig. 19 shows, one reason was a rapid deterioration of O-rings.

Fig. 19: O-rings deteriorating rapidly, leading to internal sealing oil leakage

The solution has been to change the O-ring material and to introduce an uncut backup ring design. To mount the new uncut backup ring, an expander tool must be used.

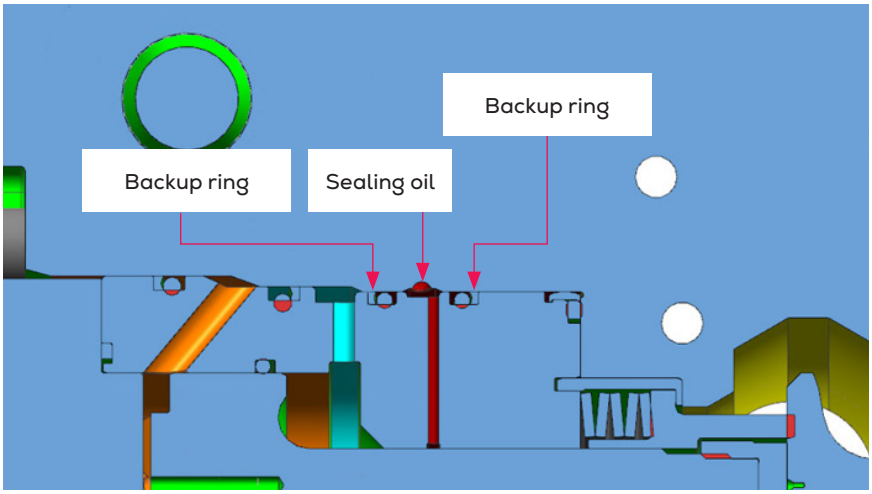
Fig. 20: Updated design with different O-rings and new backup rings

Fig. 20 shows the design solution, which resolved the leakage issue from the WVFC.

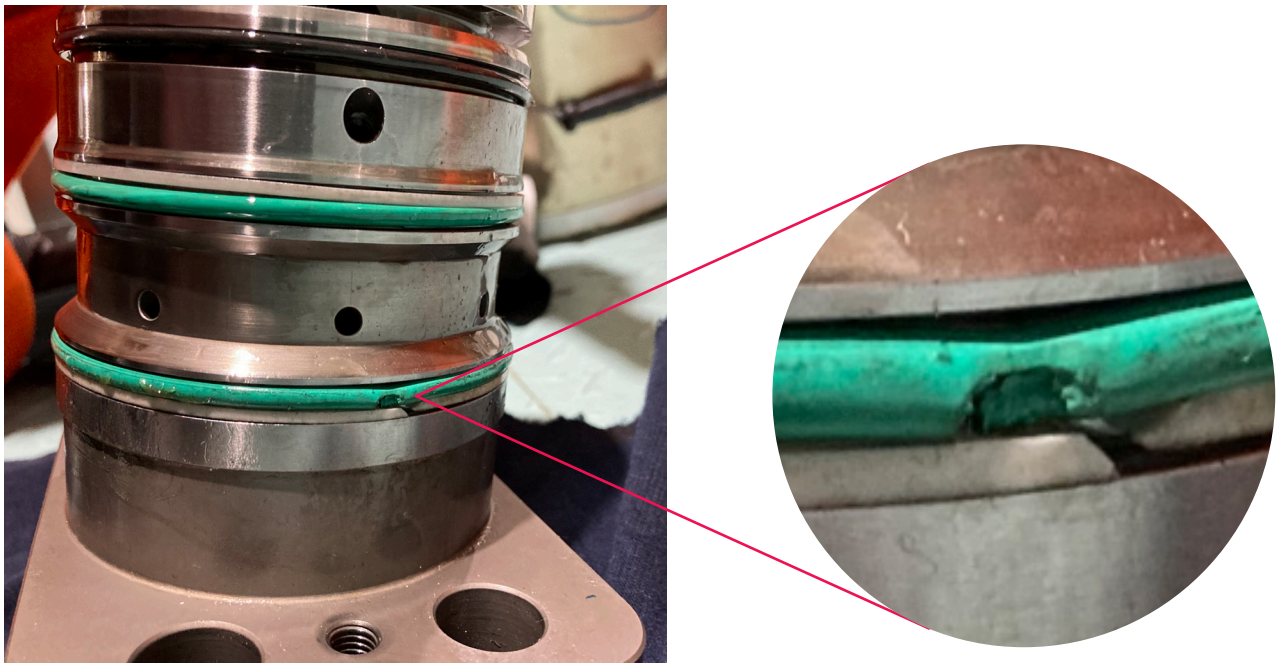
The leakage would get progressively worse until it affected the operation of the window valve, eventually causing dual-fuel shutdown and switch to liquid fuel oil mode. The window valve had a backup ring with an oblique cut that could damage the O-ring, and lead to its rupture. Fig. 22 shows the backup ring and the oblique cut damaging the O-ring.

Fig. 22: The backup ring and the oblique cut damaging the O-ring

The solution has been to introduce an uncut backup ring design. Also in this case, an expander tool must be used to mount the new backup ring. Fig. 23 shows all eight positions where the sealing design has been updated for the WVFC and window valve in new engine production and engines in service.

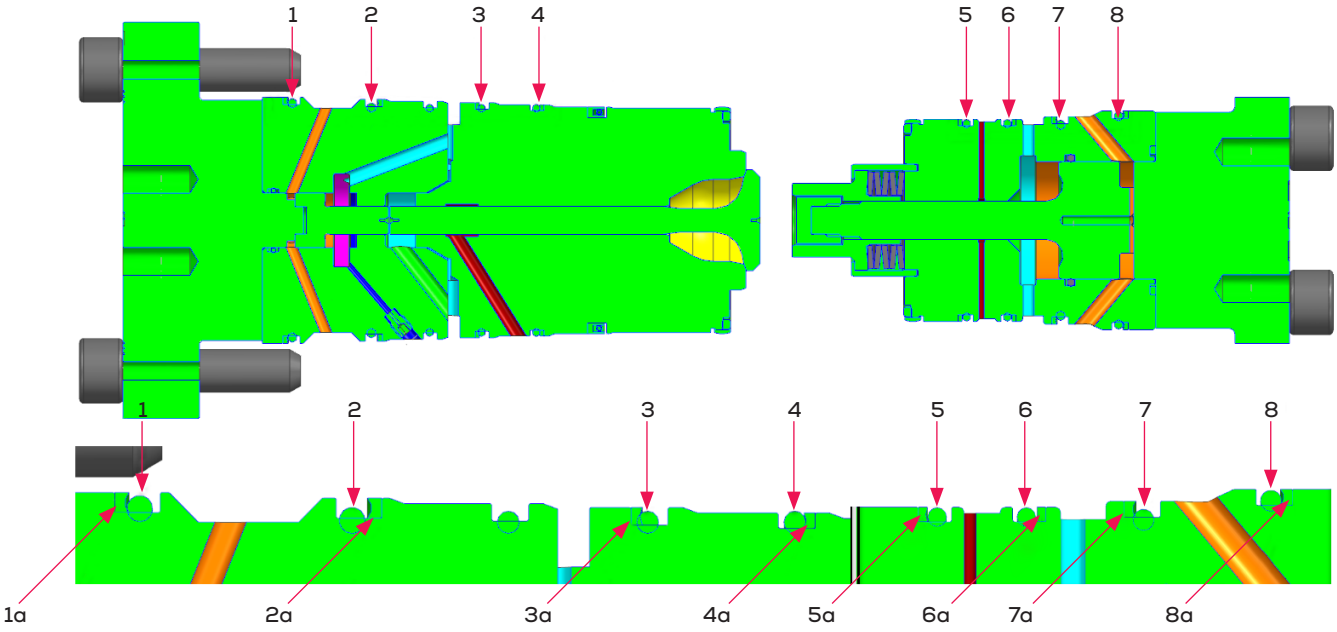
Fig. 23: Eight positions where the sealing design has been updated for the WVFC and window valve

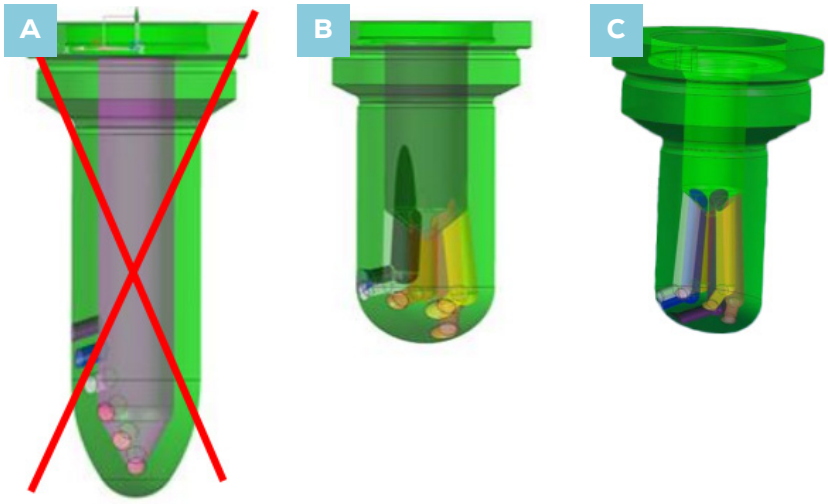
The original long design of gas nozzles suffers from hot corrosion. Fig. 24 shows an example of heavily hot-corroded long nozzles from a G60ME-C10.5-GI Mk. 2 engine.

The extra-short nozzle design in Fig. 25 is running without clogging and with acceptable levels of hot corrosion for 8,000 hours in G70ME-C9.5 engines. However, clogging remains an issue for G70ME-C10.5 engines, where nozzles that are 5 mm longer will be tested as a potential solution.

Fig. 25: a) Original long nozzle, b) temporary short nozzle, and c) extra-short nozzle

To achieve an optimal nozzle tip temperature and prevent hot corrosion while avoiding nozzle clogging, the shorter nozzle designs in Fig. 25 have been investigated. The temperature of the nozzle tip is an important parameter in avoiding nozzle hot corrosion and clogging.

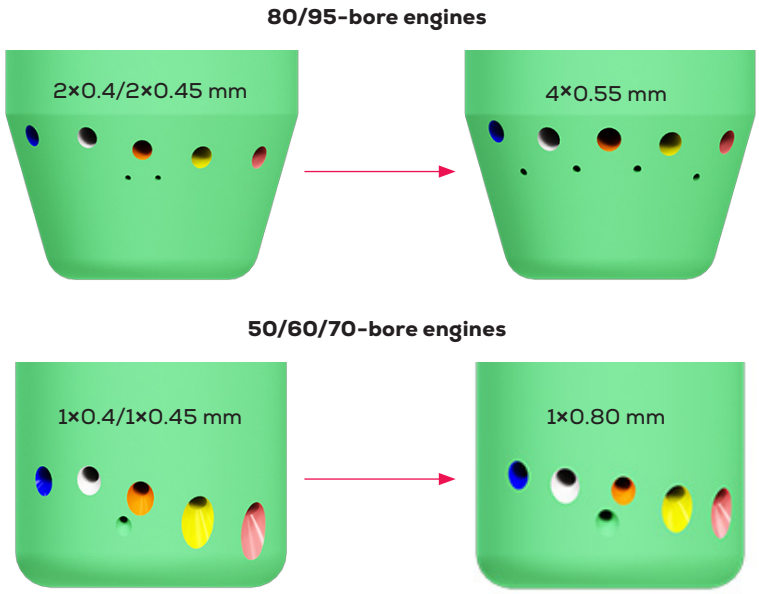
Presently, a PIV nozzle in H13 tool steel is being service-tested, and the crack issue is under control. However, this nozzle suffers from clogging of the small pilot oil injector holes. Fig. 29 shows the test setup for testing larger pilot oil injection holes and an increased number of injection holes to reduce the frequency of clogging.

Fig. 29: Nozzles with larger pilot oil injection holes and an increased number of injection holes

For 80- and 95-bore engines, the nozzle tested will have four pilot oil injection holes, each with a 0.55 mm diameter, instead of two holes with 0.4 mm diameter for 80-bore engines and two with 0.45 mm diameter for 95-bore engines. For 50-, 60- and 70-bore engines, the nozzle being tested will have one pilot injection hole with a diameter of 0.8 mm, replacing the previous configuration of one hole with 0.4 mm diameter for 50-bore engines and one with 0.45 mm diameter for 60 and 70 bore engines, respectively. However, the test program has been delayed due to the need for amendments to the IMO technical file before testing can commence.

As a short-term countermeasure, we recommend deactivating the reduced lift (RELI) function. This will reduce the risk of clogging; however, it will increase the pilot oil amount somewhat.

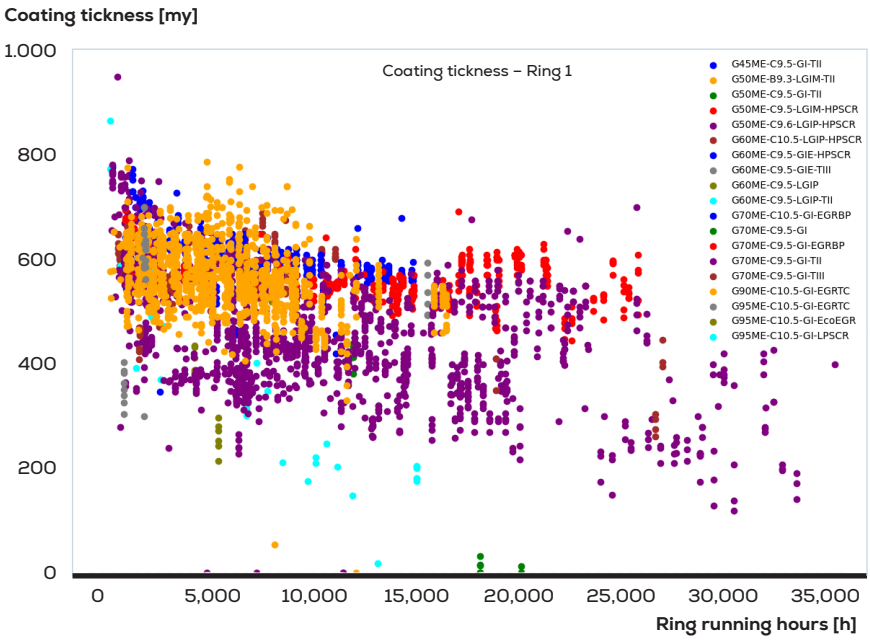
Fig. 30: Plot of top ring coating measurements for all dual-fuel engine types. Data includes over 35,000 piston ring running hours

coating is meant as a 'lifetime' coating. Our database of coating thickness recordings for all sizes of ME-GI engines in Fig. 30 demonstrates a remarkably long coating lifetime, easily achieving 32,000 hours (or five years) of operation between piston overhauls.

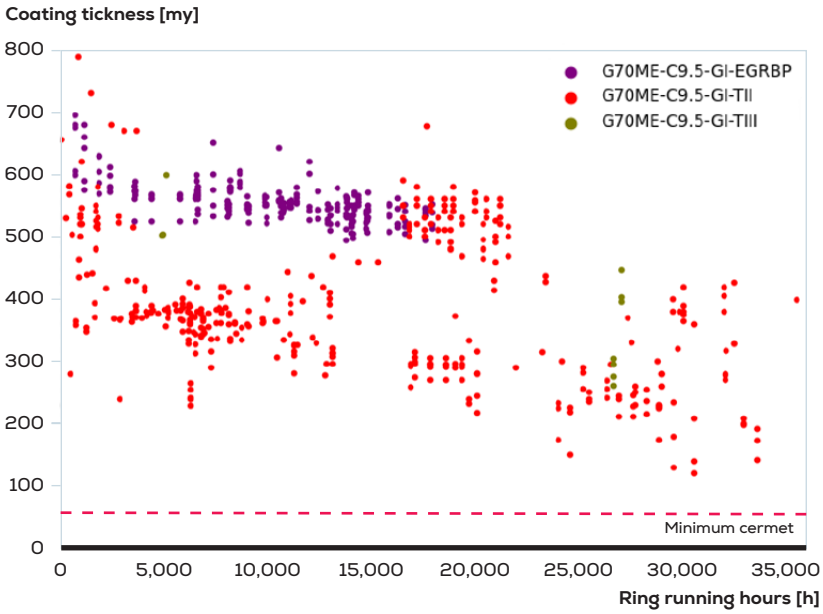
Naturally, there may be occasions when earlier piston overhauls are necessary due to other factors, such as piston ring breakage or loss of tension. However, dock-to-dock operation without piston overhaul is standard practice for today's ME-GI-powered fleet. Fig. 31 presents a subset of cermet coating thickness data for the G70-C9.5-GI engine, which has the highest number of running hours.

Fig. 31: Measurement of cermet coating thickness on the first piston ring. Data collected from nine vessels, encompassing 17 engines and a total of 85 cylinder units, over a five-year service period

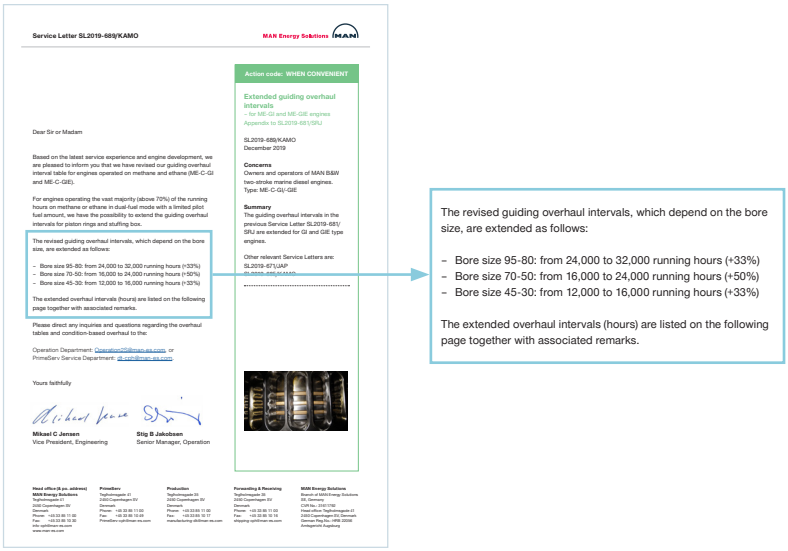
Service Letter SL2019-689/KAMO

Fig. 32: Service Letter issued in 2019 (SL2019-689), extending the time-based piston overhaul interval from 16,000 hours to 24,000 hours for 70-bore ME-GI/GIE engines due to the low wear

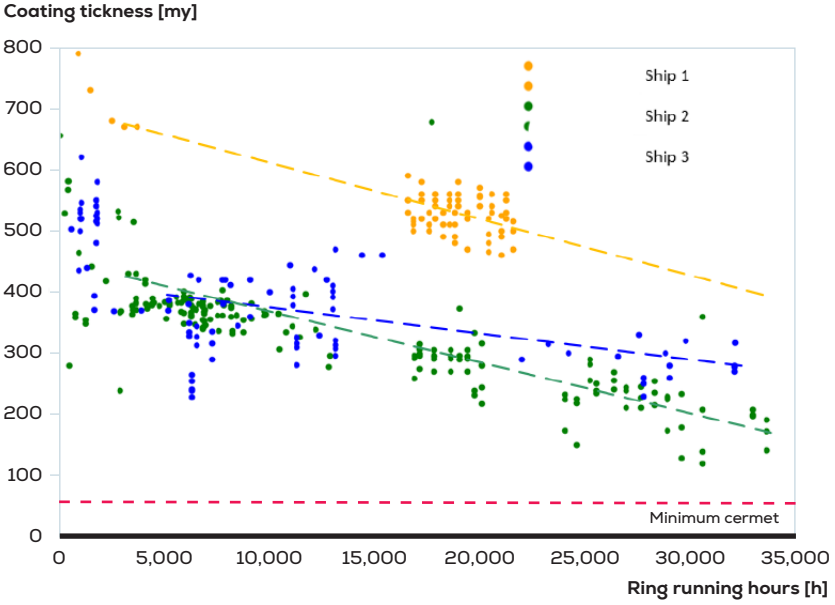
However, data indicates that a further extension of time-based intervals beyond 24,000 hours is possible – see Fig. 33.

Fig. 33: Cermet coating thickness on the first piston ring, measured on three ships and a total of 30 cylinder units

Currently, some owners are already benefiting from condition-based piston overhaul intervals of 32,000 hours, allowing for dock-to-dock operations with five years between dockings.

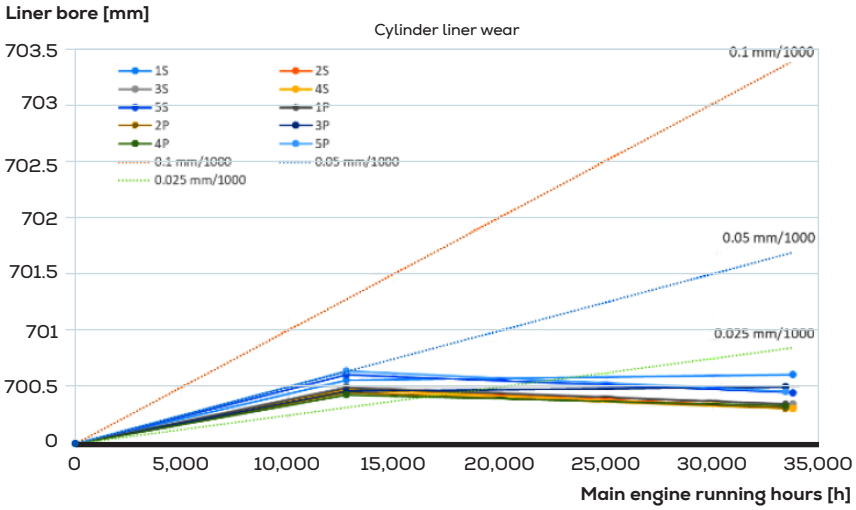
Fig. 34 shows a further subset of data for G70ME-C9.5-GI engines, indicating very low cylinder liner wear.

Fig. 34: Measurement of cylinder liner wear during a five-year service period In fact, the cylinder lifetime approaches the engine lifetime
