This paper describes the service experience gained from G60-, G70-, G80-, and G95-GI engine types.

Service experience for Everllence B&W ME-GI two-stroke engines

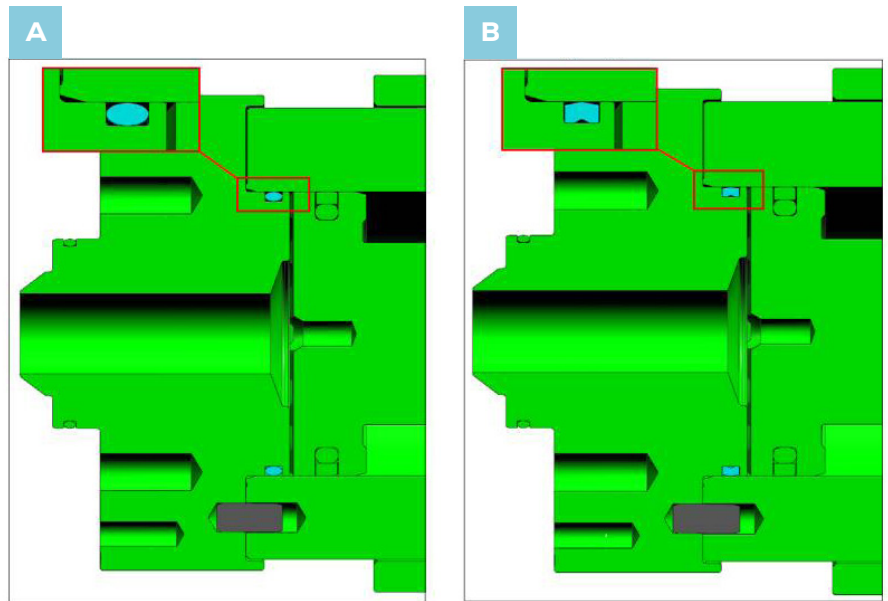
Leakage has been observed in most types of PBIV across various engine types. The root cause has been identified as the Viton O-ring in the top cover (Fig. 11), which becomes too soft and eventually disintegrates.

Fig. 13 compares the design of the old Viton O-ring (a) and the new PU seal (b).

Fig. 13: a) Old O-ring design versus b) new PU seal

The new PU seal has resolved the leakage issue on the top cover of PBIV.

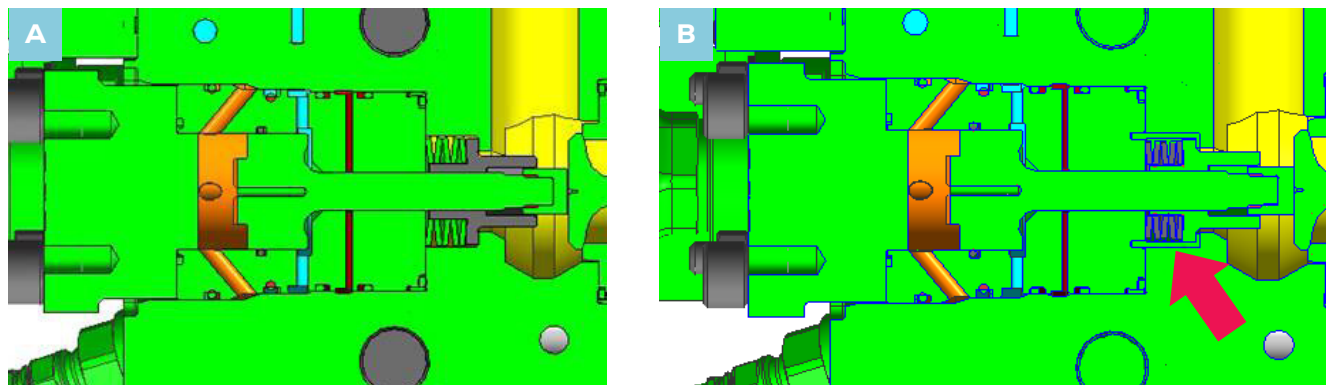
This design change has eliminated the risk of springs dropping down and the associated risk of gas block damage during WVFC assembly. Fig. 17 shows a schematic illustration of gas block damage because the Belleville spring had dropped down during the installation of the original WVFC design.

Fig. 18: Comparison of a) the original and b) the new WVFC design with a spring cup

which has been updated with a spring cup to prevent damage to the gas block.

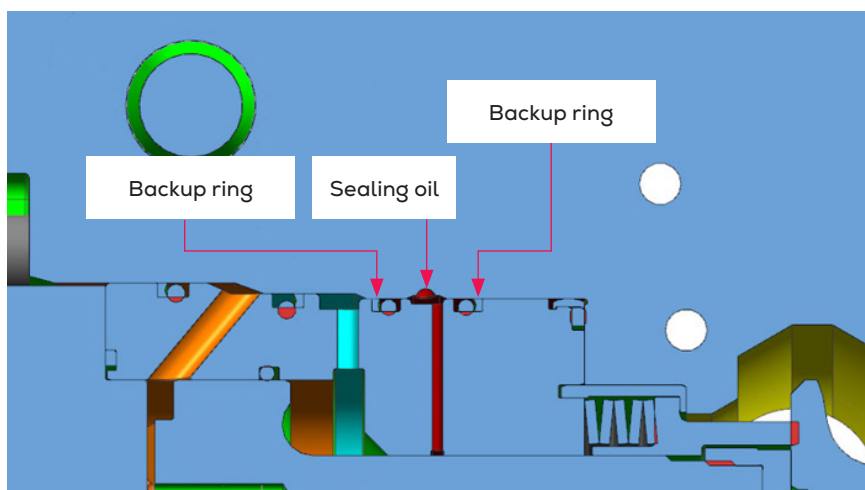
In the WVFC, O-rings kept breaking, leaking sealing oil internally to either the outer pipe or sealing oil return/drain lines. As Fig. 19 shows, one reason was a rapid deterioration of O-rings.

Fig. 20: Updated design with different O-rings and new backup rings

Fig. 20 shows the design solution, which resolved the leakage issue from the WVFC.

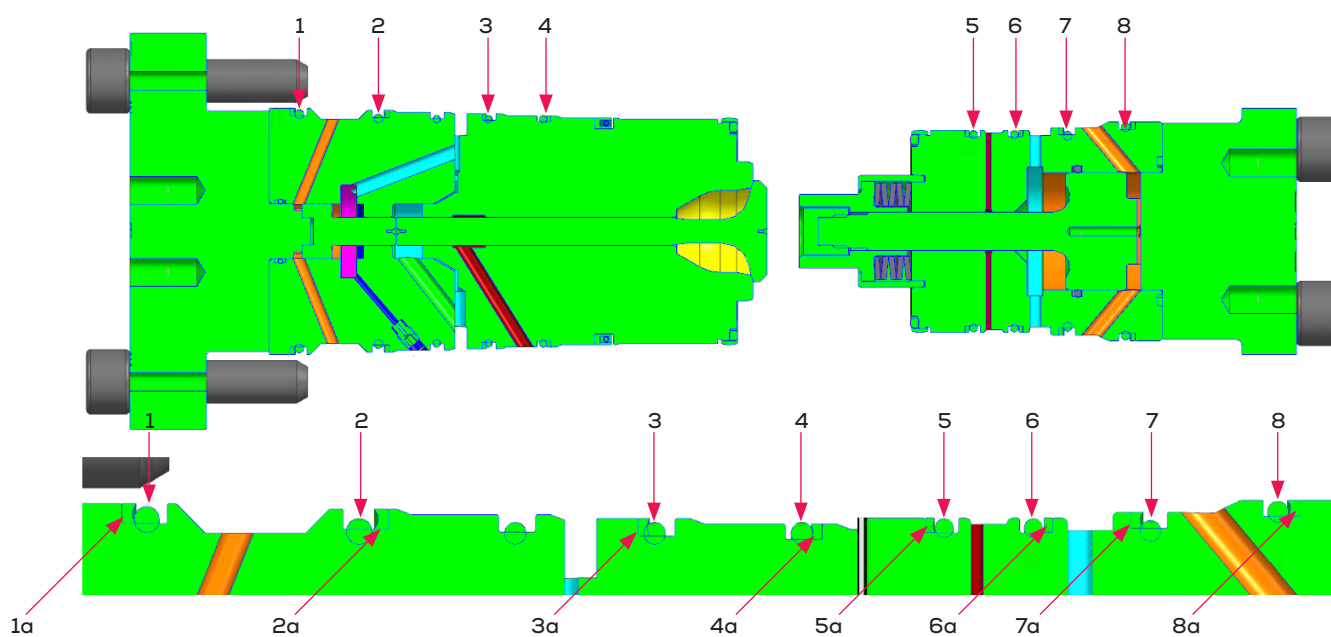
The leakage would get progressively worse until it affected the operation of the window valve, eventually causing dual-fuel shutdown and switch to liquid fuel oil mode. The window valve had a backup ring with an oblique cut that could

Fig. 23: Eight positions where the sealing design has been updated for the WVFC and window valve

expander tool must be used to mount the new backup ring. Fig. 23 shows all eight positions where the sealing design has been updated for the WVFC and window valve in new engine production and engines in service.

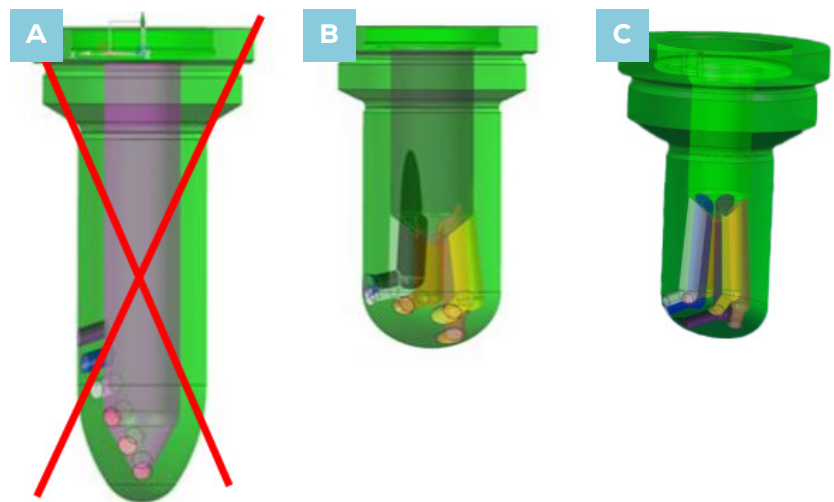
The original long design of gas nozzles suffers from hot corrosion. Fig. 24 shows an example of heavily hot-corroded long nozzles from a G60ME-C10.5-GI Mk. 2 engine.

The extra-short nozzle design in Fig. 25 is running without clogging and with acceptable levels of hot corrosion for 8,000 hours in G70ME-C9.5 engines. However, clogging remains an issue for G70ME-C10.5 engines, where nozzles that are 5 mm longer will be tested as a potential solution.

Fig. 25: a) Original long nozzle, b) temporary short nozzle, and c) extra-short nozzle

To achieve an optimal nozzle tip temperature and prevent hot corrosion while avoiding nozzle clogging, the shorter nozzle designs in Fig. 25 have been investigated. The temperature of the nozzle tip is an important parameter in avoiding nozzle hot corrosion and clogging.

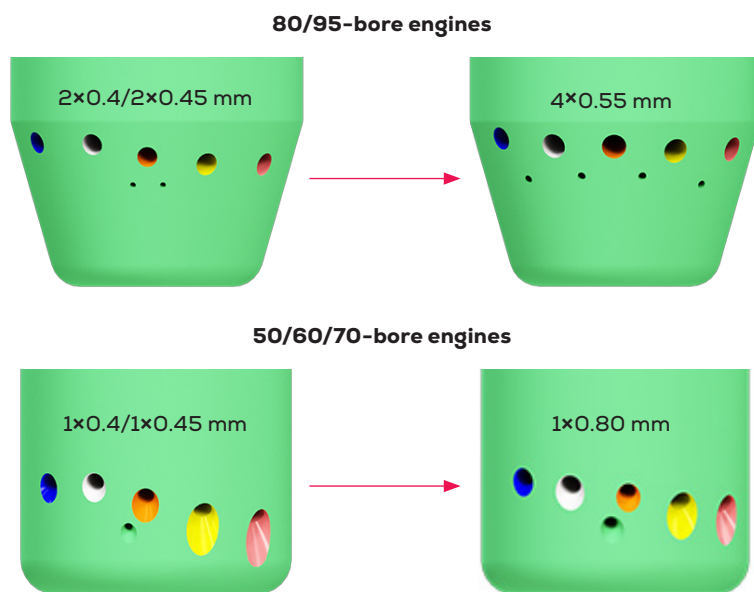
In several instances, the original compound-type PIV nozzle has experienced cracking caused by thermal fatigue, as shown in Fig. 28.

Presently, a PIV nozzle in H13 tool steel is being service-tested, and the crack issue is under control. However, this nozzle suffers from clogging of the small pilot oil injector holes. Fig. 29 shows the test setup for testing larger pilot oil injection holes and an increased number of injection holes to reduce the frequency of clogging.

Fig. 29: Nozzles with larger pilot oil injection holes and an increased number of injection holes

As a short-term countermeasure, we recommend deactivating the reduced lift (RELI) function and introducing corresponding modifications to the system parameter file (SPAF). This will reduce the risk of clogging; however, it will increase the pilot oil amount somewhat.

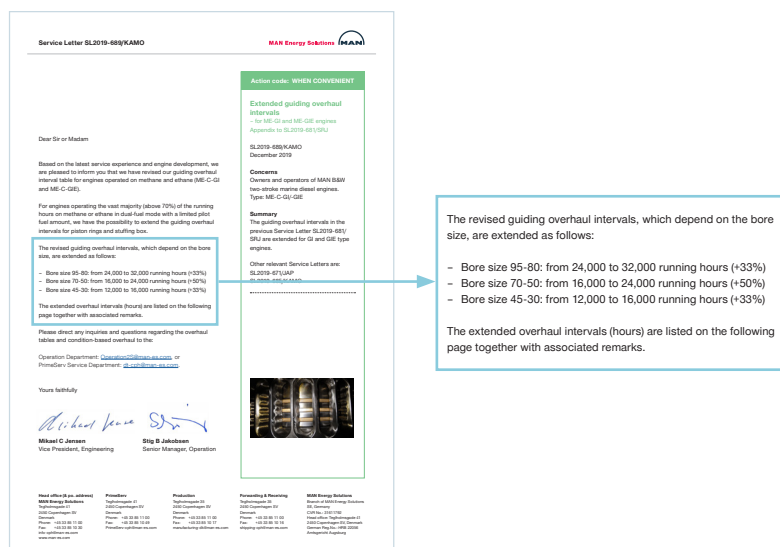
In 2019, the Service Letter in Fig. 32 was issued to announce the extension of the piston overhaul interval for 70-bore engines from 16,000 to 24,000 hours – a decision based on the data in Fig. 30 and Fig. 31.

Fig. 32: Service Letter issued in 2019 (SL2019-689), extending the time-based piston overhaul interval from 16,000 hours to 24,000 hours for 70-bore ME-GI/GIE engines due to the low wear
