Two-stroke

Copenhagen, February 2026

Action code: AT FIRST OPPORTUNITY

Cavitation in hydraulic push rod for exhaust valve

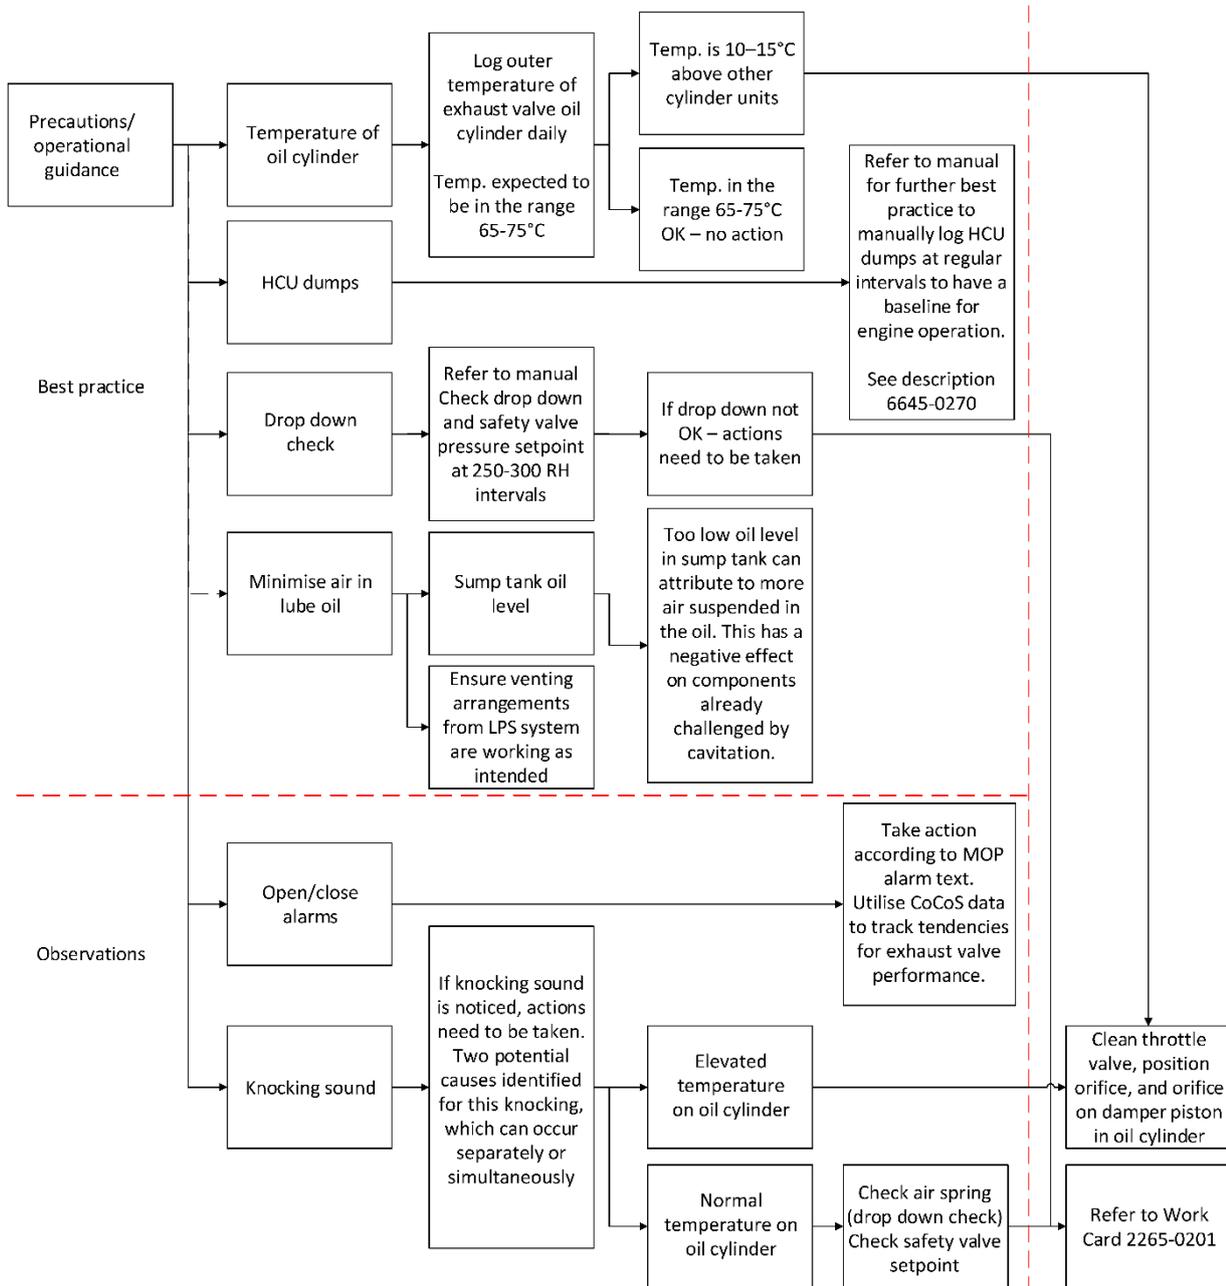
Fig. 5: Flowchart (LPS=low-pressure supply)

If hydraulic cavitation is suspected, follow the flowchart in Fig. 5 for operational guidance.

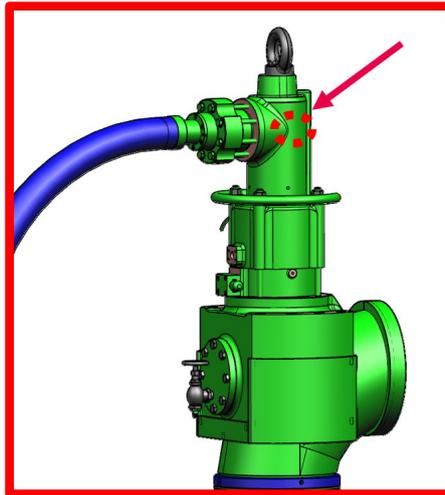
Fig. 6: Position for temperature measurement

We recommend measuring the oil cylinder temperature daily using a log sheet, see an example in Table 7. Make a mark on each unit to measure the temperature in the same location at each inspection, see Fig. 6 for correct position.

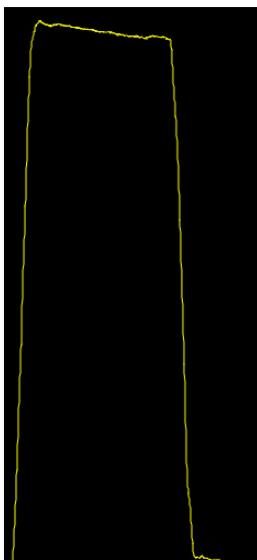
Fig. 9: For comparison – HCU dump showing normal exhaust valve opening/closing
