This paper describes the service experience gained from G50-, S60- and G60-LGIP engine types.

## Service experience for Everllence B&W ME-LGIP engines

# Service experience for Everllence B&W ME-LGIP two-stroke engines

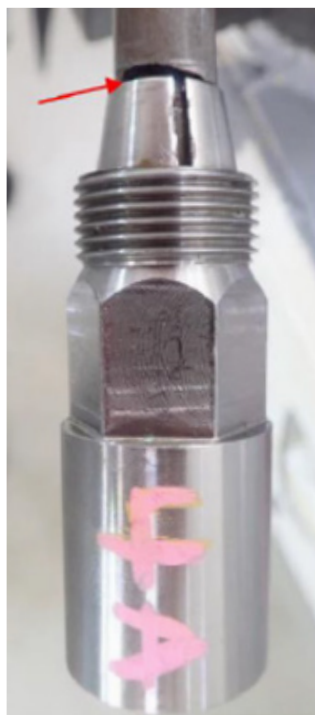
Fig. 3: Original cone design (inner cone indicated by the red arrow)

Recently, it has been identified that the cone design in hydraulic high-pressure pipes needs updating due to the risk of hydraulic leakage and shutdown during dual-fuel operation. Fig. 3 and Fig. 4 illustrate the original and new designs of the cone, respectively, and Fig. 4 also includes a simulation of the stress distribution of the new cone design.

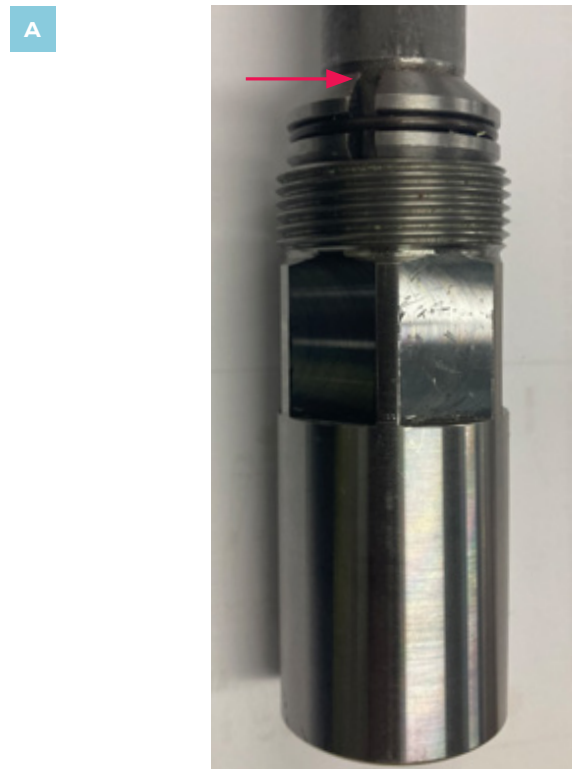
Fig. 4: New 45° cone design (indicated by the red arrow) with a smooth transition to the inner pipe and b) stress simulation of the new cone design

The new cone design has a 45° cone and a smooth transition to the inner pipe, which has lowered the stress level in the hydraulic pipe connection and also reduced the risk of pipe breakage. Hydraulic pipes with the new design will be supplied to operators of LGIP engines.

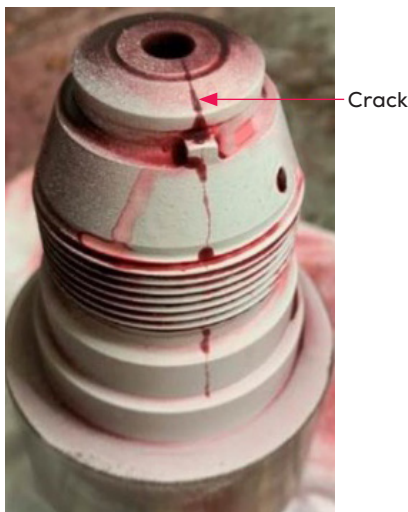
During an examination of spindle guides, it was found that nearly all of them showed cracks. Fig. 9 shows an example of the cracked area on the spindle guide. The cracked spindle guides are believed to be another cause of low mean pressure alarms.

Fig. 9: Cracked spindle guide

The cracks were not discovered in the test rig for fuel injection equipment onboard the vessels, since the testing pressure is lower than the pressure in the engine.

Fatigue simulations of the spindle guide geometry were

performed using a finite element (FEM) analysis, focusing on the cracked area. The FEM analysis revealed that the wall in the high-pressure booster chamber is too thin, which leads to fatigue and spindle guide material failure. Modifying the geometry of the booster chamber and using a thicker wall (Fig. 10), reduced the fatigue stress.

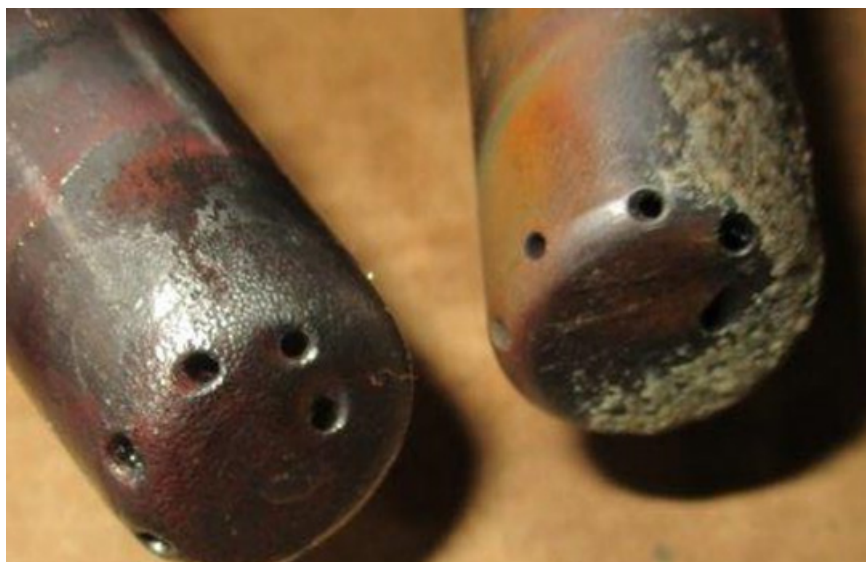
Fig. 22: Inconel nozzles, which have completed over 5,000 running hours in LGIP engine service tests

Fig. 22 shows Inconel nozzles, which have been in service in LGIP engines for more than 5,000 running hours.
