Two-stroke

Maintenance and testing of Alpha cylinder lubricator

Type: ME-C, ME-B and MC-C

Summary

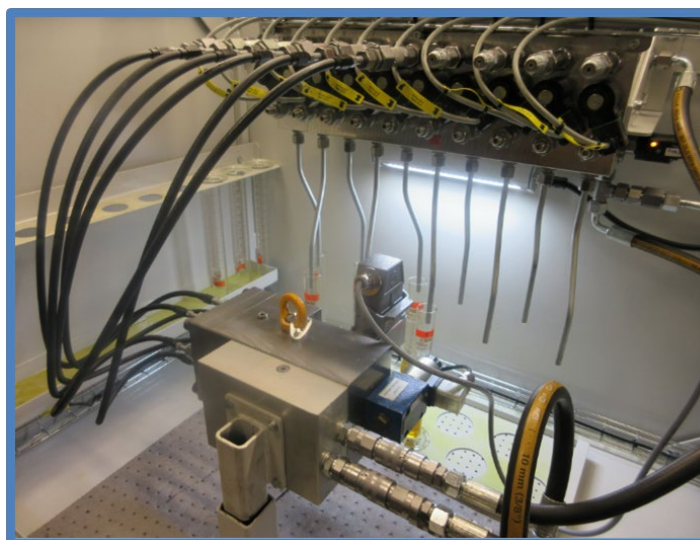
Fig. 2: Alpha lubricator in test rig

- Operational testing using a lubricator test rig (Fig. 2), including:
 - Standard overhaul
 - Flow and leakage tests according to Everllence standards
 - Improved measurement of lubricating oil output
 - Collection of test data to improve traceability and transparency in maintenance and parts usage
- Report alignment: Global standardised reporting (Figs. 3 and 4)
